Access Compliance Report

Public Rights-of-Way

(Curb Ramps)

Intersection ID: 26371	Main Street: BEVINGTON_PL	Cross Street: HEMINGFORD_CT	Location: NW
ADA ID: 7F6DB58C2E91	Ramp Type: PerpDiag	Initial Pass/Fail: Fail	Overall Compliance: No
		Severity Score: 25

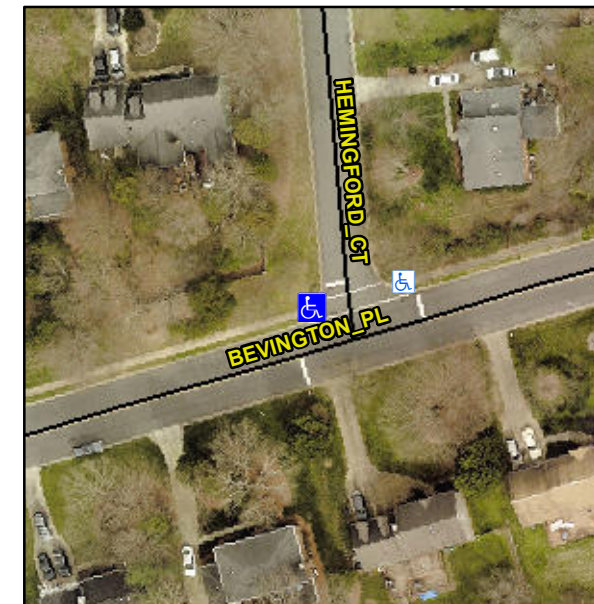
Not Found, R304.5.3

Compliance	Description	Data	Compliance	Description	Data
N/A	Ramp Length (in)	32.0	Yes	Ramp Slope (%)	6.1
Yes	Ramp Width (in)	48.0	No	Ramp XSlope (%)	8.2
N/A	Flare Type LT	N/A	N/A	Flare Type RT	N/A
N/A	Flare Slope LT (%)	N/A	N/A	Flare Slope RT (%)	N/A
N/A	Flare Traversable LT?	N/A	N/A	Flare Traversable RT?	N/A
N/A	Landing Length (in)	N/A	N/A	DWS Provided?	N/A
N/A	Landing Width (in)	N/A	N/A	DWS Contrast?	N/A
N/A	Landing Slope (%)	N/A	N/A	DWS Length (in)	N/A
N/A	Landing X Slope (%)	N/A	N/A	DWS Full Width?	N/A
N/A	Landing Curb? (Y/N)	N/A	N/A	DWS Offset (in)	N/A
N/A	Shared Landing?	N/A			
N/A	Gutter Ponding?	N/A	N/A	Gutter Slope (%)	N/A
N/A	Gutter Lip Ht (in)	N/A	N/A	Gutter X Slope (%)	N/A
N/A	Painted X Walk1?	No	N/A	Painted X Walk2?	Yes
	X Walk 1 Direction	To S		X Walk 2 Direction	To E
N/A	X Walk 1 Width (in)	N/A	N/A	X Walk 2 Width (in)	108.0
	X Walk 1 Slope (%)	1.4		X Walk 2 Slope (%)	0.1
	X Walk 1 X Slope (%)	0.8		X Walk 2 X Slope (%)	10.3

N/A	Ramp inside XWalk1?	N/A	N/A	Ramp inside XWalk2?	Yes
	Road Slope (%)	5.3	N/A	Clear Space?	N/A
	Road X Slope (%)	8.1	N/A	Clear Space to XWalk (in)	N/A
N/A	Any Obstructions?	N/A	N/A	Storm Grate/Utility Hazard?	N/A
	Obstruction Type			Storm Grate/Utility Type	
		N/A			N/A
			Yes	Surface Condition? (G/P)	Good

Remove & Replace Curb Ramp With Two New Directional Ramps or Equivalent.
