Access Compliance Report

Public Rights-of-Way

(Curb Ramps)

| Intersection ID: 53180 | Main Street: ELLINGTON_PARK_DR | Cross Street: BASIE_PARK_CT | Location: SE |

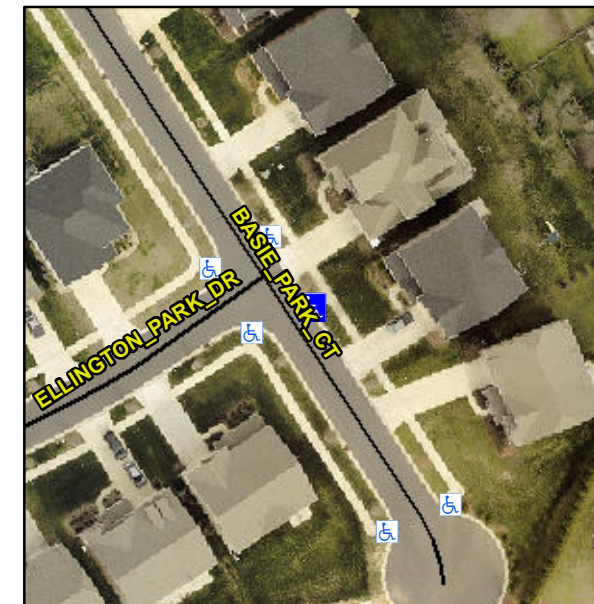
Not Found, R304.2.2-Perp, R304.3.2-Para, R305.2

| Compliance | Description | Data | Compliance | Description | Data |
|---|---|---|---|---|---|
| No | Landing Slope (%) | 2.2 | Yes | DWS Length (in) | 24.0 |
| N/A | Landing Curb? (Y/N) | No | No | DWS Offset (in) | 5.5 |

Possible Solutions:

Remove & Replace Entire Ramp.

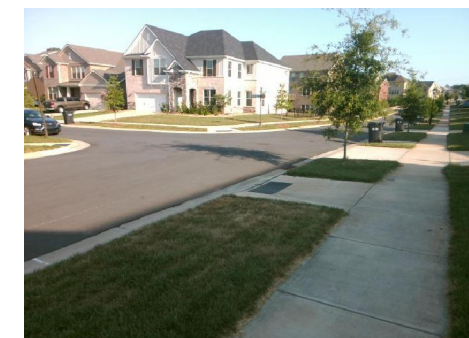
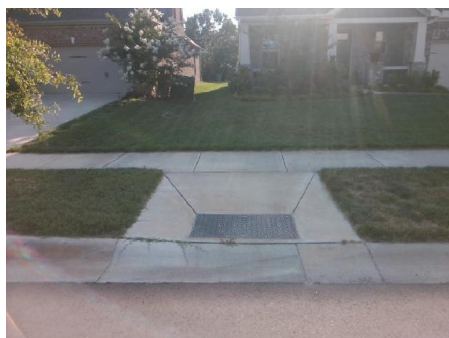
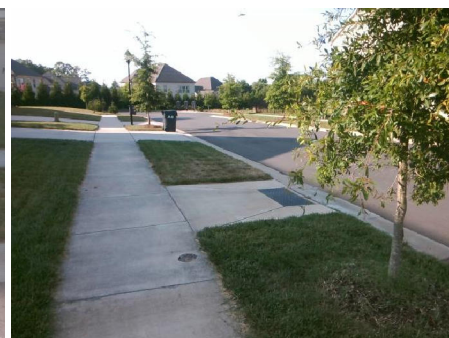
| Compliance | Description | Data | Compliance | Description | Data |
|---|---|---|---|---|---|
| | | | Yes | Surface Condition? (G/P) | Good |
