Access Compliance Report

Public Rights-of-Way (Curb Ramps)

Intersection ID: 14281	Main Street: E_KINGSTON_AV	Cross Street: LYNDHURST_AV	Location: S
ADA ID: 7F7EE50C5C80	Ramp Type: Directional1	Initial Pass/Fail: Fail	Overall Compliance: No
		Severity Score: 1.25

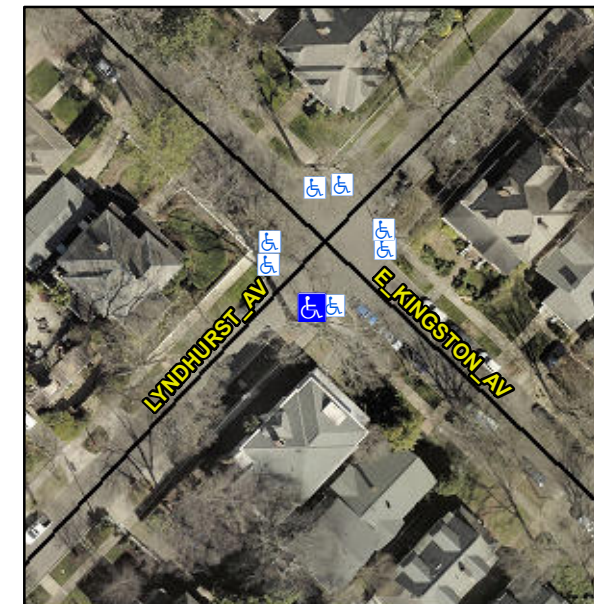
Compliance	Description	Data	Compliance	Description	Data
N/A	Ramp Length (in)	84.0	N/A	Grade Break?	N/A
Yes	Ramp Width (in)	65.0	N/A	Grade Break Slope (%)	0.0
Yes	Ramp Slope (%)	3.1	N/A	Grade Break XSlope (%)	0.0
No	Ramp XSlope (%)	2.1			
N/A	Flare Type LT	N/A	N/A	Flare Type RT	N/A
N/A	Flare Slope LT (%)	N/A	N/A	Flare Slope RT (%)	0.0
N/A	Flare Traversable LT?	N/A	N/A	Flare Traversable RT?	N/A
N/A	Landing Length (in)	0.0	N/A	DWS Provided?	N/A
N/A	Landing Width (in)	0.0	N/A	DWS Contrast?	N/A
N/A	Landing Slope (%)	0.0	N/A	DWS Length (in)	N/A
N/A	Landing X Slope (%)	0.0	N/A	DWS Full Width?	N/A
N/A	Landing Curb? (Y/N)	N/A	N/A	DWS Offset LT (in)	N/A
N/A	Shared Landing?	N/A	N/A	DWS Offset RT (in)	N/A
N/A	Gutter Ponding?	0.0	N/A	Gutter Slope (%)	N/A
N/A	Gutter Lip Ht (in)	0.0	N/A	Gutter X Slope (%)	N/A
N/A	Painted X Walk1?	No		Road Slope (%)	2.1
	X Walk 1 Direction	To NW		Road X Slope (%)	0.1
	X Walk 1 Width (in)	N/A		Clear Space?	N/A

X Walk 1 Slope (%)	2.1	N/A	Clear Space to XWalk (in)	N/A
	X Walk 1 X Slope (%)	0.1	N/A	Storm Grate/Utility Hazard?	N/A
N/A	Ramp inside XWalk1?	N/A		Storm Grate/Utility Type	
N/A	Any Obstructions?	N/A			N/A
	Obstruction Type		Yes	Surface Condition? (G/P)	Good
			N/A	Curb Slope (%)	2.6

Possible Solutions:

Remove & Replace Entire Ramp.

R304.5.3
