Access Compliance Report

Public Rights-of-Way

(Curb Ramps)

Intersection ID: 11003	Main Street: CAMP_GREENE_ST	Cross Street: RINGWOOD_ST	Location: SW
ADA ID: 7F9B16CFE90B	Ramp Type: PerpDiag	Initial Pass/Fail: Fail	Overall Compliance: No
Codes/Mitigation Info/Possible Solution			Severity Score: 10
			Field Measurements/Component Compliance

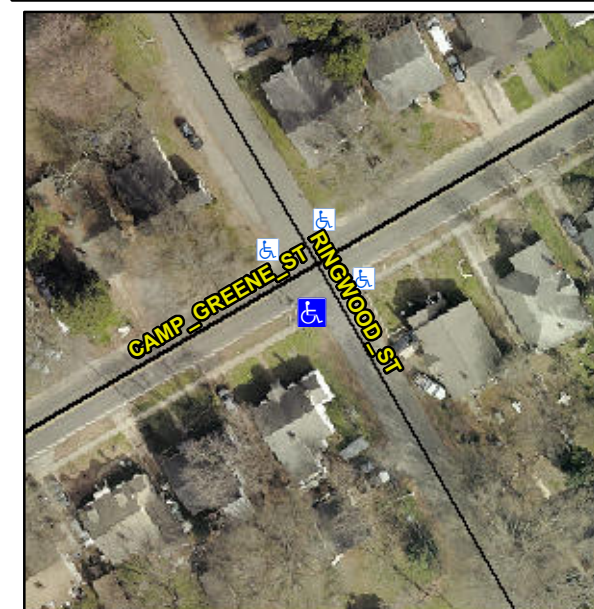
Compliance	Description	Data	Compliance	Description	Data
N/A	Ramp Length (in)	61.0	Yes	Ramp Slope (%)	6.6
No	Ramp Width (in)	47.5	No	Ramp XSlope (%)	2.4
N/A	Flare Type LT	N/A	N/A	Flare Type RT	N/A
N/A	Flare Slope LT (%)	N/A	N/A	Flare Slope RT (%)	N/A
N/A	Flare Traversable LT?	N/A	N/A	Flare Traversable RT?	N/A
N/A	Landing Length (in)	N/A	N/A	DWS Provided?	N/A
N/A	Landing Width (in)	N/A	N/A	DWS Contrast?	N/A
N/A	Landing Slope (%)	N/A	N/A	DWS Length (in)	N/A
N/A	Landing X Slope (%)	N/A	N/A	DWS Full Width?	N/A
N/A	Landing Curb? (Y/N)	N/A	N/A	DWS Offset (in)	N/A
N/A	Shared Landing?	N/A			
N/A	Gutter Ponding?	N/A	N/A	Gutter Slope (%)	N/A
N/A	Gutter Lip Ht (in)	0.5	N/A	Gutter X Slope (%)	N/A
N/A	Painted X Walk1?	No	N/A	Painted X Walk2?	No
	X Walk 1 Direction	To E		X Walk 2 Direction	To N
N/A	X Walk 1 Width (in)	N/A	N/A	X Walk 2 Width (in)	N/A
	X Walk 1 Slope (%)	5.4		X Walk 2 Slope (%)	0.9
	X Walk 1 X Slope (%)	1.4		X Walk 2 X Slope (%)	4.0

N/A	Ramp inside XWalk1?	N/A	N/A	Ramp inside XWalk2?	N/A
	Road Slope (%)	4.8	N/A	Clear Space?	N/A
	Road X Slope (%)	4.3	N/A	Clear Space to XWalk (in)	N/A
N/A	Any Obstructions?	N/A	N/A	Storm Grate/Utility Hazard?	N/A
	Obstruction Type			Storm Grate/Utility Type	
		N/A			N/A
			Yes	Surface Condition? (G/P)	Good

Possible Solutions:

Remove & Replace Curb Ramp With Two New Directional Ramps or Equivalent.

R304.5.1, R304.5.3
