# Access Compliance Report

## Public Rights-of-Way (Curb Ramps)

| Intersection ID: 10038264 | Main Street: SMITH_RD | Cross Street: N/A | Location: NW |
| ADA ID: 7F9B79C7D453 | Ramp Type: Perp | Initial Pass/Fail: Fail | Overall Compliance: No<br>Severity Score: 13.75 |

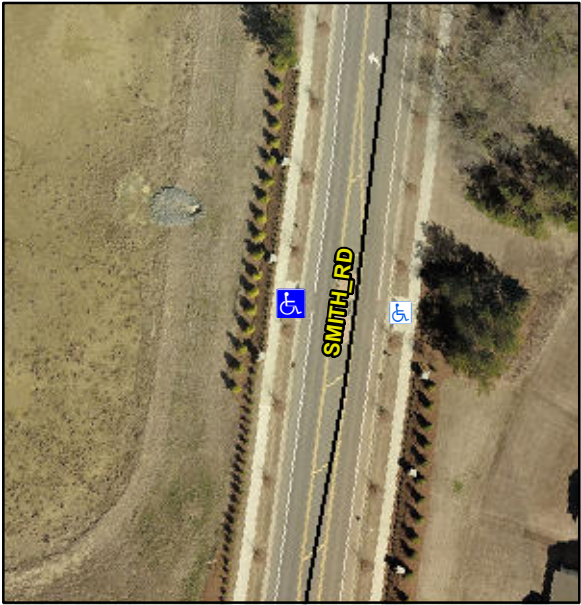
| Codes/Mitigation Info/Possible Solution | | | Field Measurements/Component Compliance | | |
|---|---|--|---|---|---|
| | <b>Remove &amp; Replace Entire Ramp.</b> | | <b>No</b> | Ramp Length (in) | <b>95.0</b> |
| <p>Surveyor Notes:</p> <p><b>N/A</b></p> <p>PROW/ADA:</p> <p><b>Not Found, R304.2.2, R304.5.3</b></p> | | | <b>N/A</b> | Flare Type RT | <b>N/A</b> |

| Codes/Mitigation Info/Possible Solution | | | Field Measurements/Component Compliance | | |
|---|---|--|---|---|---|
| | Possible Solutions: | | <b>Compliance</b> | <b>Description</b> | <b>Data</b> |
