Access Compliance Report

Public Rights-of-Way

(Curb Ramps)

| Intersection ID: 10036062 | Main Street: RIVERGATE_PY | Cross Street: N/A | Location: NW |

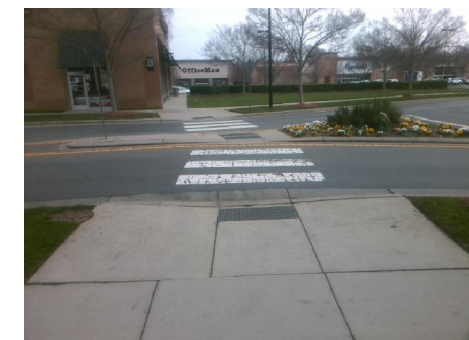
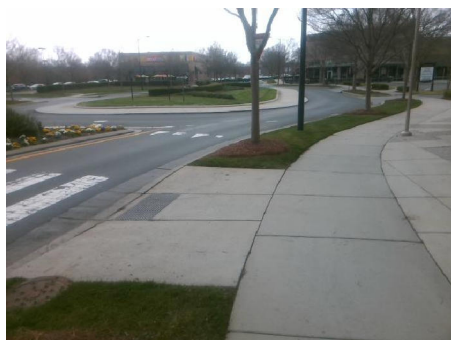
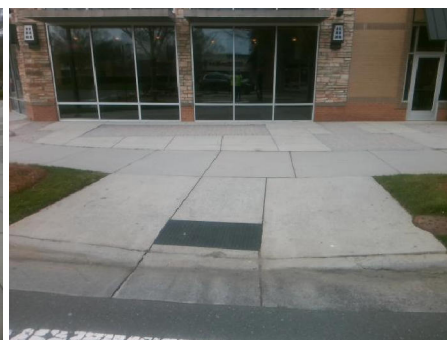
| ADA ID: 7FA6E0F8D11B | Ramp Type: Perp | Initial Pass/Fail: Fail | Overall Compliance: No |

R304.5.1, R304.5.3

| Compliance | Description | Data | Compliance | Description | Data |
|---|---|---|---|---|---|
| N/A | Ramp Length (in) | 96.0 | Yes | Ramp Slope (%) | 6.9 |
| No | Ramp Width (in) | 44.0 | No | Ramp XSlope (%) | 2.6 |

Remove & Replace Entire Ramp.

Total Cost: \$ 1850.00
