Access Compliance Report

Public Rights-of-Way

(Curb Ramps)

| Intersection ID: 11900 | Main Street: CLARKSON_GREEN_ST | Cross Street: GREENLEAF_AV | Location: S |

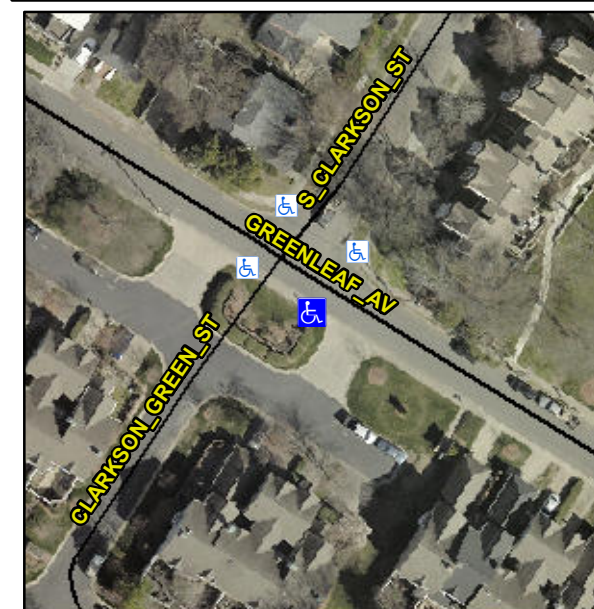
R304.5.1, R304.2.2, R304.5.3

| Compliance | Description | Data | Compliance | Description | Data |
|---|---|---|---|---|---|
| N/A | Ramp Length (in) | 48.0 | No | Ramp Slope (%) | 10.9 |
| No | Ramp Width (in) | 40.0 | No | Ramp XSlope (%) | 3.3 |

Remove & Replace Entire Ramp.
