Intersection ID: 16358	Main Street: BILLINGSLEY_RD	Cross Street: ELLINGTON_ST	Location:	NE
ADA ID: 7FC35CEE48BE	Ramp Type: PerpDiag	Initial Pass/Fail: Fail	Overall Compliance: No	Severity Score: 21.25

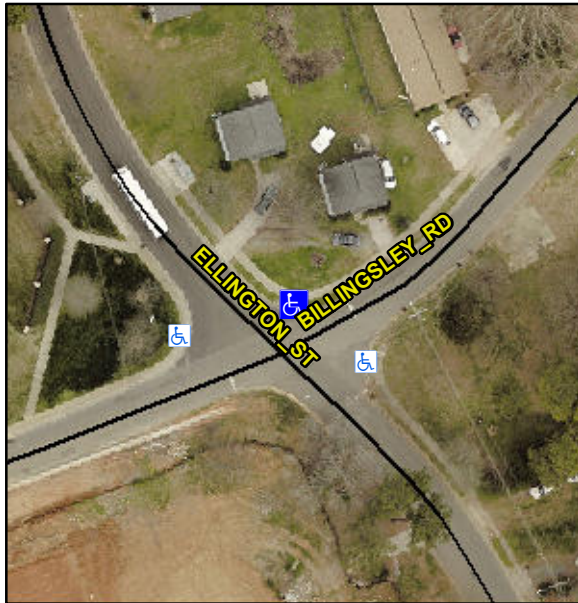
Not Found, R304.5.1, R304.2.2

Compliance	Description	Data	Compliance	Description	Data
N/A	Ramp Length (in)	48.0	No	Ramp Slope (%)	8.6
No	Ramp Width (in)	44.0	Yes	Ramp XSlope (%)	0.8
N/A	Flare Type LT	N/A	N/A	Flare Type RT	N/A
N/A	Flare Slope LT (%)	N/A	N/A	Flare Slope RT (%)	N/A
N/A	Flare Traversable LT?	N/A	N/A	Flare Traversable RT?	N/A
N/A	Landing Length (in)	N/A	N/A	DWS Provided?	N/A
N/A	Landing Width (in)	N/A	N/A	DWS Contrast?	N/A
N/A	Landing Slope (%)	N/A	N/A	DWS Length (in)	N/A
N/A	Landing X Slope (%)	N/A	N/A	DWS Full Width?	N/A
N/A	Landing Curb? (Y/N)	N/A	N/A	DWS Offset (in)	N/A
N/A	Shared Landing?	N/A			
N/A	Gutter Ponding?	N/A	N/A	Gutter Slope (%)	N/A
N/A	Gutter Lip Ht (in)	N/A	N/A	Gutter X Slope (%)	N/A
N/A	Painted X Walk1?	No	N/A	Painted X Walk2?	No
	X Walk 1 Direction	To SW		X Walk 2 Direction	To SE
N/A	X Walk 1 Width (in)	N/A	N/A	X Walk 2 Width (in)	N/A
	X Walk 1 Slope (%)	5.3		X Walk 2 Slope (%)	8.0
	X Walk 1 X Slope (%)	6.6		X Walk 2 X Slope (%)	4.8

N/A	Ramp inside XWalk1?	N/A	N/A	Ramp inside XWalk2?	N/A
	Road Slope (%)	0.3	N/A	Clear Space?	N/A
	Road X Slope (%)	9.4	N/A	Clear Space to XWalk (in)	N/A
N/A	Any Obstructions?	N/A	N/A	Storm Grate/Utility Hazard?	N/A
	Obstruction Type			Storm Grate/Utility Type	
		N/A			N/A
			Yes	Surface Condition? (G/P)	Good

Possible Solutions:

Remove & Replace Curb Ramp With Two New Directional Ramps or Equivalent.
