# Access Compliance Report

## Public Rights-of-Way

### (Curb Ramps)

Intersection ID: 18104	Main Street: ROBIN_RD	Cross Street: S_SHARON_AMITY_RD	Location: S
ADA ID: 7FCBB00E73D8	Ramp Type: PerpDiag	Initial Pass/Fail: Fail	Overall Compliance: No
		Severity Score: 33.75

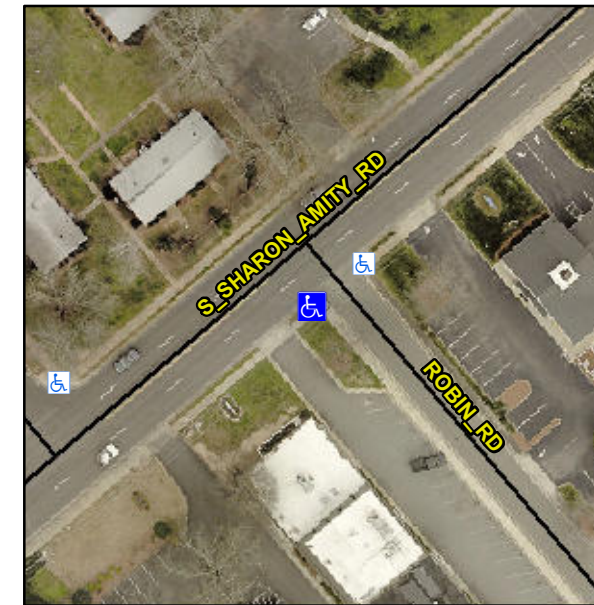
**Not Found, R304.5.1, R304.2.2**

Compliance	Description	Data	Compliance	Description	Data
N/A	Ramp Length (in)	45.0	No	Ramp Slope (%)	13.0
No	Ramp Width (in)	40.0	Yes	Ramp XSlope (%)	0.0
N/A	Flare Type LT	N/A	N/A	Flare Type RT	N/A
N/A	Flare Slope LT (%)	N/A	N/A	Flare Slope RT (%)	N/A
N/A	Flare Traversable LT?	N/A	N/A	Flare Traversable RT?	N/A
N/A	Landing Length (in)	N/A	N/A	DWS Provided?	N/A
N/A	Landing Width (in)	N/A	N/A	DWS Contrast?	N/A
N/A	Landing Slope (%)	N/A	N/A	DWS Length (in)	N/A
N/A	Landing X Slope (%)	N/A	N/A	DWS Full Width?	N/A
N/A	Landing Curb? (Y/N)	N/A	N/A	DWS Offset (in)	N/A
N/A	Shared Landing?	N/A			
N/A	Gutter Ponding?	N/A	N/A	Gutter Slope (%)	N/A
N/A	Gutter Lip Ht (in)	N/A	N/A	Gutter X Slope (%)	N/A
N/A	Painted X Walk1?	No	N/A	Painted X Walk2?	No
	X Walk 1 Direction	To NE		X Walk 2 Direction	To NW
N/A	X Walk 1 Width (in)	N/A	N/A	X Walk 2 Width (in)	N/A
	X Walk 1 Slope (%)	0.0		X Walk 2 Slope (%)	5.6
	X Walk 1 X Slope (%)	0.6		X Walk 2 X Slope (%)	2.1

**Remove & Replace Curb Ramp With Two New Directional Ramps or Equivalent.**
