Access Compliance Report

Public Rights-of-Way

(Curb Ramps)

Intersection ID: 50998	Main Street: S_TRYON_ST	Cross Street: STEELECROFT_PY	Location: NW
ADA ID: 7FD9951AB4BF	Ramp Type: Perp	Initial Pass/Fail: Fail	Overall Compliance: No
Severity Score: 12.5			
Codes/Mitigation Info/Possible Solution		Field Measurements/Component Compliance

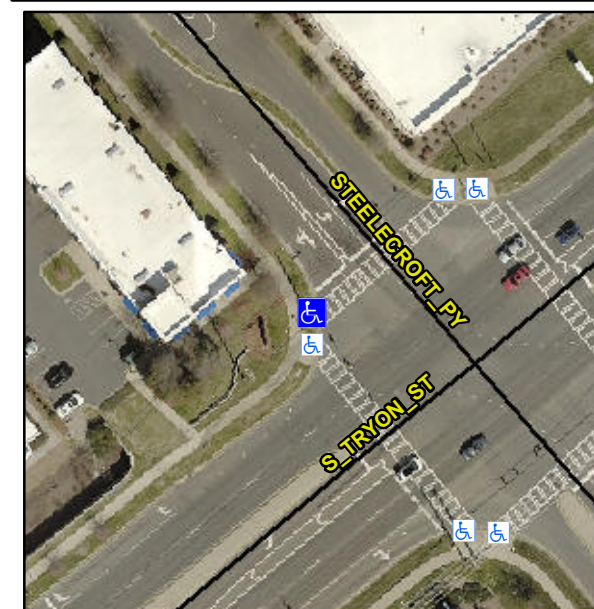
Not Found, R304.2.2

Compliance	Description	Data	Compliance	Description	Data
N/A	Ramp Length (in)	100.0	No	Ramp Slope (%)	10.1
Yes	Ramp Width (in)	48.0	Yes	Ramp XSlope (%)	0.4
N/A	Flare Type LT	N/A	N/A	Flare Type RT	N/A
N/A	Flare Slope LT (%)	N/A	N/A	Flare Slope RT (%)	N/A
N/A	Flare Traversable LT?	N/A	N/A	Flare Traversable RT?	N/A
N/A	Landing Length (in)	N/A	N/A	DWS Provided?	N/A
N/A	Landing Width (in)	N/A	N/A	DWS Contrast?	N/A
N/A	Landing Slope (%)	N/A	N/A	DWS Length (in)	N/A
N/A	Landing X Slope (%)	N/A	N/A	DWS Full Width?	N/A
N/A	Landing Curb? (Y/N)	N/A	N/A	DWS Offset (in)	N/A
N/A	Shared Landing?	N/A			
N/A	Gutter Ponding?	N/A	N/A	Gutter Slope (%)	N/A
N/A	Gutter Lip Ht (in)	N/A	N/A	Gutter X Slope (%)	N/A
N/A	Painted X Walk1?	Yes	N/A	Painted X Walk2?	N/A
	X Walk 1 Direction	To NE		X Walk 2 Direction	N/A
N/A	X Walk 1 Width (in)	111.0	N/A	X Walk 2 Width (in)	N/A
	X Walk 1 Slope (%)	2.6		X Walk 2 Slope (%)	N/A
	X Walk 1 X Slope (%)	3.8		X Walk 2 X Slope (%)	N/A

Remove & Replace Entire Ramp.

Total Cost: \$ 1850.00
