Access Compliance Report

Public Rights-of-Way

(Curb Ramps)

Intersection ID: N/A	Main Street: CANTERBURY_CASTLE_DR	Cross Street: SAGMORE_HILL_DR	Location: S
ADA ID: 7FDFEB8F2A60	Ramp Type: BlendTrans1	Initial Pass/Fail: Fail	Overall Compliance: No
Severity Score: 8.75			
Codes/Mitigation Info/Possible Solution		Field Measurements/Component Compliance

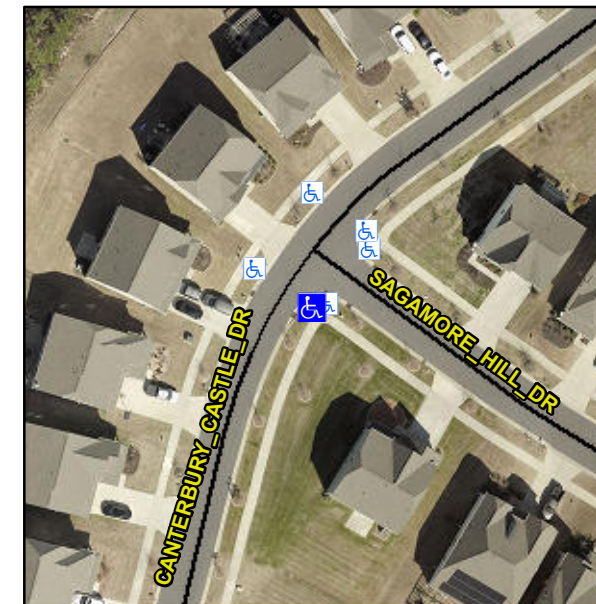
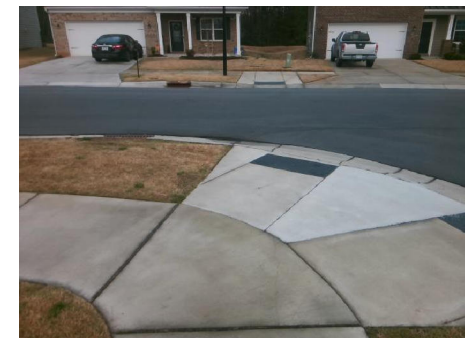
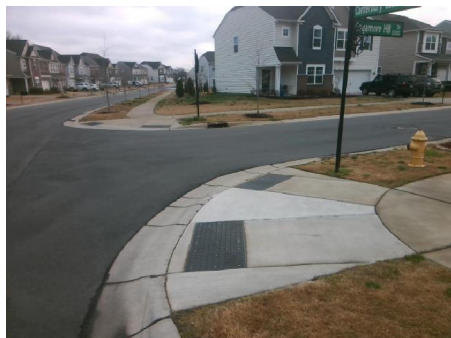
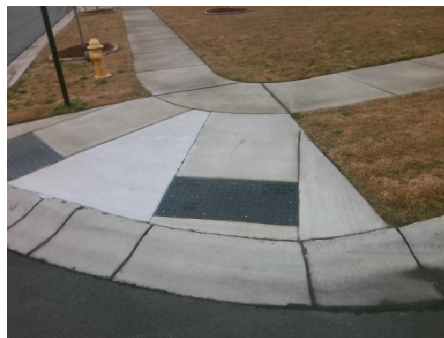
Compliance	Description	Data	Compliance	Description	Data
N/A	Ramp Length (in)	96.0	Yes	BlendTrans Slope (%)	4.2
No	Ramp Width (in)	45.5	Yes	BlendTrans XSlope (%)	0.5
N/A	Flare Type LT	N/A	N/A	Flare Type RT	N/A
N/A	Flare Slope LT (%)	N/A	N/A	Flare Slope RT (%)	N/A
N/A	Flare Traversable LT?	N/A	N/A	Flare Traversable RT?	N/A
N/A	Landing Length (in)	N/A	N/A	DWS Provided?	N/A
N/A	Landing Width (in)	N/A	N/A	DWS Contrast?	N/A
N/A	Landing Slope (%)	N/A	N/A	DWS Length (in)	N/A
N/A	Landing X Slope (%)	N/A	N/A	DWS Full Width?	N/A
N/A	Landing Curb? (Y/N)	N/A	N/A	DWS Offset (in)	N/A
N/A	Shared Landing?	N/A			
N/A	Gutter Ponding?	N/A	N/A	Gutter Slope (%)	N/A
N/A	Gutter Lip Ht (in)	N/A	N/A	Gutter X Slope (%)	N/A
N/A	Painted X Walk1?	No	N/A	Painted X Walk2?	N/A
	X Walk 1 Direction	To NW		X Walk 2 Direction	N/A
	X Walk 1 Width (in)	N/A		X Walk 2 Width (in)	N/A
	X Walk 1 Slope (%)	2.8		X Walk 2 Slope (%)	N/A
	X Walk 1 X Slope (%)	1.9		X Walk 2 X Slope (%)	N/A

N/A	Ramp inside XWalk1?	N/A	N/A	Ramp inside XWalk2?	N/A
	Road Slope (%)	1.9		Clear Space?	N/A
	Road X Slope (%)	2.8	N/A	Clear Space to XWalk (in)	N/A
N/A	Any Obstructions?	N/A	N/A	Storm Grate/Utility Hazard?	N/A
	Obstruction Type			Storm Grate/Utility Type	
		N/A			N/A
			Yes	Surface Condition? (G/P)	Good
			N/A	Curb Slope (%)	2.2

Remove & Replace Curb Ramp With Two New Directional Ramps or Equivalent.

R304.5.1
