# Access Compliance Report

## Public Rights-of-Way

### (Curb Ramps)

Intersection ID: 10608	Main Street: N_DAVIDSON_ST	Cross Street: JORDAN_PL	Location: SE
ADA ID: 7FE16CB0B751	Ramp Type: Perp	Initial Pass/Fail: Fail	Overall Compliance: No
		Severity Score: 8.75

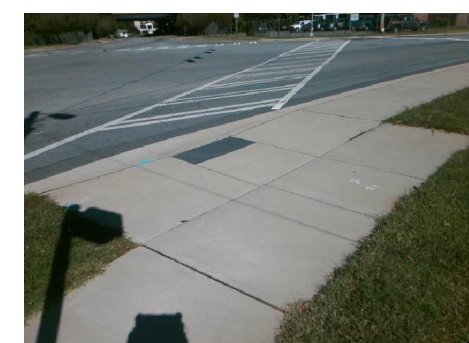
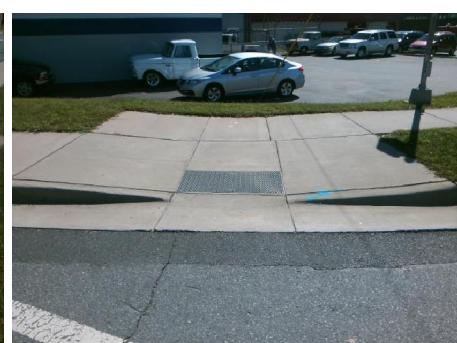
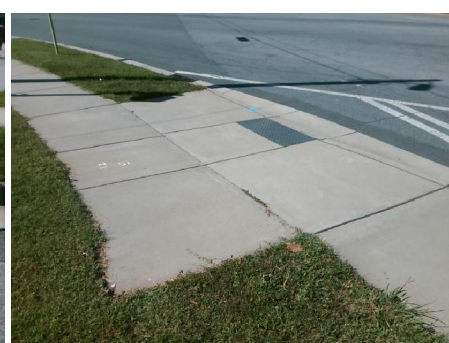
Possible Solutions:		<b>Compliance</b>	<b>Description</b>	<b>Data</b>
	<b>Remove &amp; Replace Entire Ramp.</b>		<b>Yes</b>	Ramp Length (in)	130.0
			<b>No</b>	Ramp Width (in)	42.5
			<b>N/A</b>	Flare Type LT	N/A
			<b>N/A</b>	Flare Slope LT (%)	N/A
			<b>N/A</b>	Flare Traversable LT?	N/A
			<b>N/A</b>	Landing Length (in)	N/A
			<b>N/A</b>	Landing Width (in)	N/A
			<b>N/A</b>	Landing Slope (%)	N/A
			<b>N/A</b>	Landing X Slope (%)	N/A
<p>Surveyor Notes:</p> <p><b>N/A</b></p> <p>PROW/ADA:</p> <p><b>Not Found, R304.5.1</b></p>			<b>N/A</b>	Flare Type RT	N/A
			<b>N/A</b>	Flare Slope RT (%)	N/A
			<b>N/A</b>	Flare Traversable RT?	N/A
			<b>N/A</b>	DWS Provided?	N/A
			<b>N/A</b>	DWS Contrast?	N/A
			<b>N/A</b>	DWS Length (in)	N/A
			<b>N/A</b>	DWS Full Width?	N/A
			<b>N/A</b>	DWS Offset (in)	N/A
			<b>N/A</b>	Shared Landing?	N/A

<b>N/A</b>	Gutter Ponding?	N/A
			<b>N/A</b>	Gutter Lip Ht (in)	N/A
			<b>N/A</b>	Painted X Walk1?	Yes
				X Walk 1 Direction	To NE
			<b>N/A</b>	X Walk 1 Width (in)	147.5
				X Walk 1 Slope (%)	0.7
				X Walk 1 X Slope (%)	1.1
			<b>N/A</b>	Ramp inside XWalk1?	Yes
			<b>N/A</b>	Road Slope (%)	N/A
			<b>N/A</b>	Road X Slope (%)	N/A
			<b>N/A</b>	Any Obstructions?	N/A
				Obstruction Type	
			<b>N/A</b>		
			<b>N/A</b>		
			<b>N/A</b>		
			<b>N/A</b>		
			<b>N/A</b>		
			<b>N/A</b>		
			<b>N/A</b>		
			<b>N/A</b>		
			<b>N/A</b>		
Total Cost:		\$ 1850.00			
			<b>N/A</b>		
			<b>Yes</b>	Surface Condition? (G/P)	Good
