Access Compliance Report Public Rights-of-Way (Curb Ramps)

•		. ,						
Intersection ID: 8870	Main Street: WELLS_ST				Cross Stre	et: I	NORRIS_AV	Location:	NE		
ADA ID: 800467268A4C	Ramp Ty	Ramp Type: Perp			Initial Pass/Fail: Fail Overall Compliance: No					o Severity Score:	46.25
Codes/Mitigation Info/Possible Solution					Field Measurements/Component Compliance

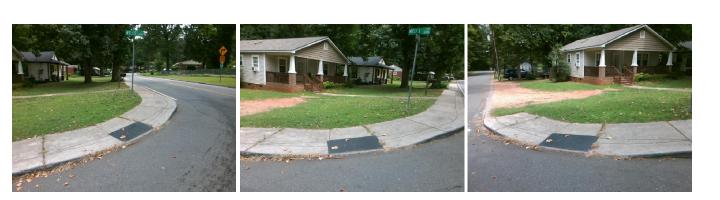
1. A.A.	Possible Solutions:			Compliance Description Data Compliance						Data
aller V. Mit.	Pro the	Remove & Re	olaco Entiro Pa	mn	N/A		Ramp Length (in)	60.5	1	Ramp Slope (%)	11.4
	~ A+1	Keniove & Ke		imp.	No		Ramp Width (in)	38.5		Ramp XSlope (%)	10.2
· a ·					N/A		Flare Type LT	N/A		Flare Type RT	N/A
	121				N/A		Flare Slope LT (%)		N/A	Flare Slope RT (%)	N/A
5					N/A		Flare Traversable LT?	N/A		Flare Traversable RT?	N/A
				N/A		Landing Length (in)		N/A	DWS Provided?	N/A	
		Surveyor Notes:			N/A		Landing Width (in)	N/A		DWS Contrast?	N/A
	1 1114	N/A			N/A		Landing Slope (%)		N/A	DWS Length (in)	N/A
NORRIG AV		IN/A			N/A		Landing X Slope (%)	N/A		DWS Full Width?	N/A
A A A A A A A A A A A A A A A A A A A	1-2-4-				N/A		Landing Curb? (Y/N)	N/A		DWS Offset (in)	N/A
THE ALL AND				N/#		Shared Landing?	N/A				
STAN ALL MAR	PROW/ADA:			N/A		Gutter Ponding?	N/A	N/A	Gutter Slope (%)	N/A	
	8	204 5 4 0 204 4		N/A		Gutter Lip Ht (in)	N/A		Gutter X Slope (%)	N/A
