Access Compliance Report

Public Rights-of-Way

(Curb Ramps)

| Intersection ID: 46189 | Main Street: GALARDIA_RD | Cross Street: YAUPON_RD | Location: SE |

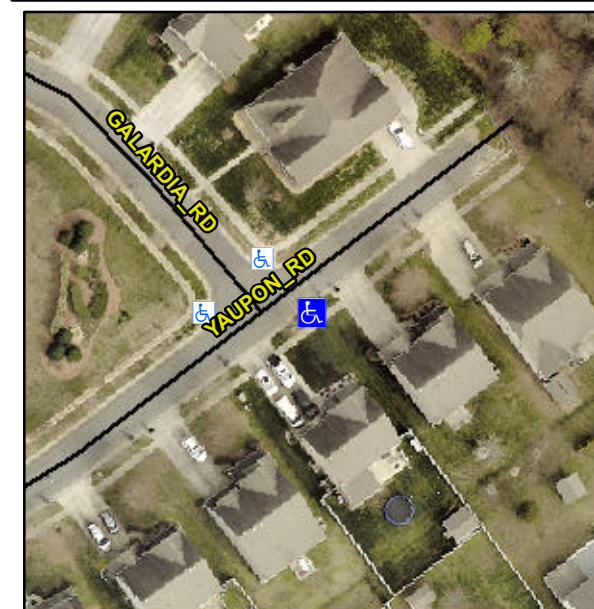
| ADA ID: 80075AE67ED3 | Ramp Type: Perp | Initial Pass/Fail: Fail | Overall Compliance: No |

Not Found, R304.5.1, R304.5.3

| Compliance | Description | Data | Compliance | Description | Data |
|---|---|---|---|---|---|
| N/A | Ramp Length (in) | 71.0 | Yes | Ramp Slope (%) | 6.3 |
| No | Ramp Width (in) | 46.5 | No | Ramp XSlope (%) | 2.6 |

Remove & Replace Entire Ramp.
