Access Compliance Report

Public Rights-of-Way

(Curb Ramps)

Intersection ID: 8113	Main Street: ORR_RD	Cross Street: GRIER_RD	Location: SE
ADA ID: 8009F18BDA0F	Ramp Type: Perp	Initial Pass/Fail: Fail	Overall Compliance: No
Codes/Mitigation Info/Possible Solution		Field Measurements/Component Compliance	
Severity Score: 21.25

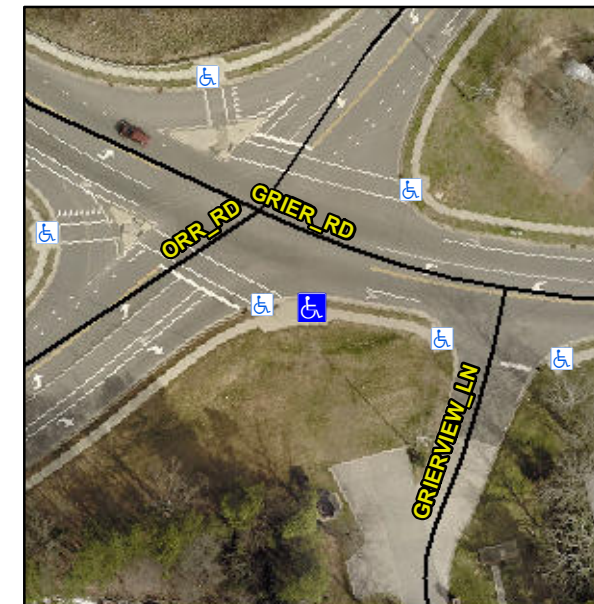
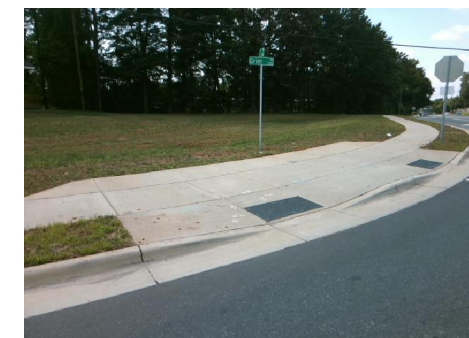
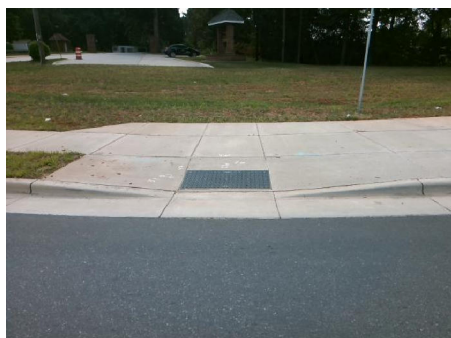
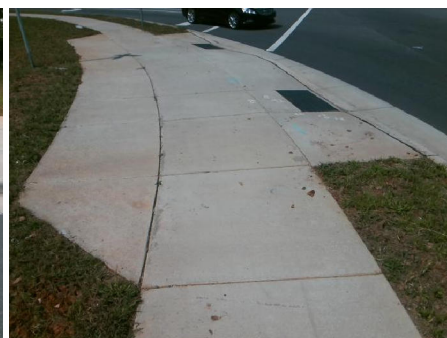
R304.5.1, R304.2.2

Compliance	Description	Data	Compliance	Description	Data
N/A	Ramp Length (in)	47.0	No	Ramp Slope (%)	9.2
No	Ramp Width (in)	47.0	Yes	Ramp XSlope (%)	2.0
N/A	Flare Type LT	N/A	N/A	Flare Type RT	N/A
N/A	Flare Slope LT (%)	N/A	N/A	Flare Slope RT (%)	N/A
N/A	Flare Traversable LT?	N/A	N/A	Flare Traversable RT?	N/A
N/A	Landing Length (in)	N/A	N/A	DWS Provided?	N/A
N/A	Landing Width (in)	N/A	N/A	DWS Contrast?	N/A
N/A	Landing Slope (%)	N/A	N/A	DWS Length (in)	N/A
N/A	Landing X Slope (%)	N/A	N/A	DWS Full Width?	N/A
N/A	Landing Curb? (Y/N)	N/A	N/A	DWS Offset (in)	N/A
N/A	Shared Landing?	N/A			
N/A	Gutter Ponding?	N/A	N/A	Gutter Slope (%)	N/A
N/A	Gutter Lip Ht (in)	N/A	N/A	Gutter X Slope (%)	N/A
N/A	Painted X Walk1?	No	N/A	Painted X Walk2?	N/A
	X Walk 1 Direction	To NE		X Walk 2 Direction	N/A
N/A	X Walk 1 Width (in)	N/A	N/A	X Walk 2 Width (in)	N/A
	X Walk 1 Slope (%)	3.1		X Walk 2 Slope (%)	N/A
	X Walk 1 X Slope (%)	0.2		X Walk 2 X Slope (%)	N/A

N/A	Ramp inside XWalk1?	N/A	N/A	Ramp inside XWalk2?	N/A
	Road Slope (%)	N/A	N/A	Clear Space?	N/A
	Road X Slope (%)	N/A	N/A	Clear Space to XWalk (in)	N/A
N/A	Any Obstructions?	N/A	N/A	Storm Grate/Utility Hazard?	N/A
	Obstruction Type			Storm Grate/Utility Type	
		N/A			N/A
			Yes	Surface Condition? (G/P)	Good

Remove & Replace Entire Ramp.

Total Cost: \$ 1850.00
