Access Compliance Report

Public Rights-of-Way

(Curb Ramps)

Intersection ID: 28257	Main Street: OLYMPIC CLUB DR	Cross Street: PINE VALLEY CLUB DR	Location: NW
ADA ID: 800C21DD53EA	Ramp Type: PerpDiag	Initial Pass/Fail: Fail	Overall Compliance: No
		Severity Score: 25

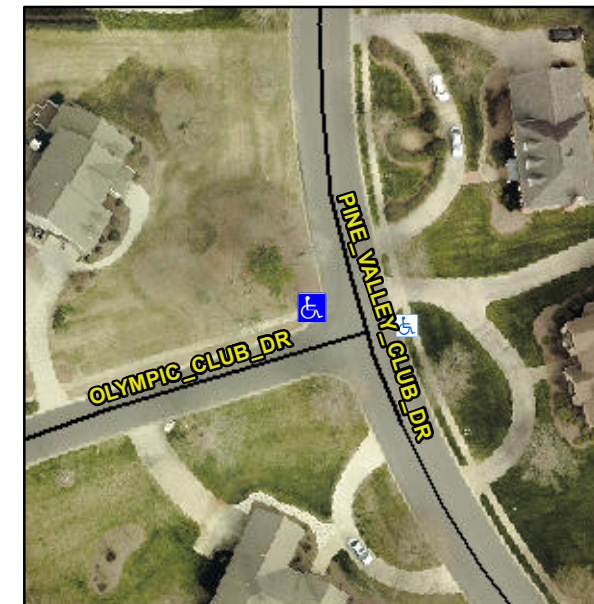
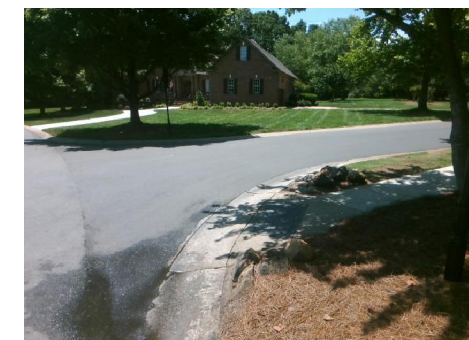
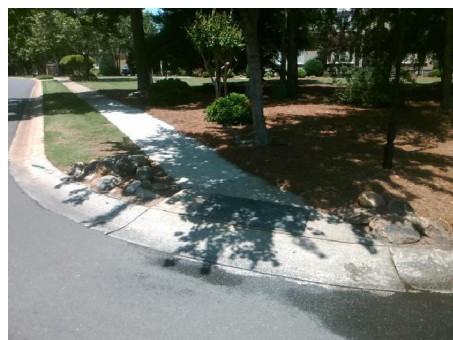
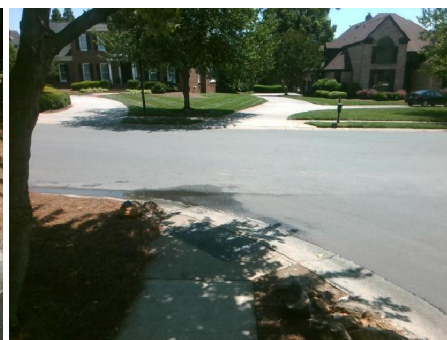
Not Found, R304.2.2, R304.5.3

Compliance	Description	Data	Compliance	Description	Data
N/A	Ramp Length (in)	48.0	No	Ramp Slope (%)	9.6
Yes	Ramp Width (in)	48.0	No	Ramp XSlope (%)	6.4
N/A	Flare Type LT	N/A	N/A	Flare Type RT	N/A
N/A	Flare Slope LT (%)	N/A	N/A	Flare Slope RT (%)	N/A
N/A	Flare Traversable LT?	N/A	N/A	Flare Traversable RT?	N/A
N/A	Landing Length (in)	N/A	N/A	DWS Provided?	N/A
N/A	Landing Width (in)	N/A	N/A	DWS Contrast?	N/A
N/A	Landing Slope (%)	N/A	N/A	DWS Length (in)	N/A
N/A	Landing X Slope (%)	N/A	N/A	DWS Full Width?	N/A
N/A	Landing Curb? (Y/N)	N/A	N/A	DWS Offset (in)	N/A
N/A	Shared Landing?	N/A			
N/A	Gutter Ponding?	N/A	N/A	Gutter Slope (%)	N/A
N/A	Gutter Lip Ht (in)	N/A	N/A	Gutter X Slope (%)	N/A
N/A	Painted X Walk1?	No	N/A	Painted X Walk2?	No
	X Walk 1 Direction	To S		X Walk 2 Direction	To SE
N/A	X Walk 1 Width (in)	N/A	N/A	X Walk 2 Width (in)	N/A
	X Walk 1 Slope (%)	1.0		X Walk 2 Slope (%)	6.8
	X Walk 1 X Slope (%)	3.4		X Walk 2 X Slope (%)	3.3

N/A	Ramp inside XWalk1?	N/A	N/A	Ramp inside XWalk2?	N/A
	Road Slope (%)	3.9	N/A	Clear Space?	N/A
	Road X Slope (%)	0.8	N/A	Clear Space to XWalk (in)	N/A
N/A	Any Obstructions?	N/A	N/A	Storm Grate/Utility Hazard?	N/A
	Obstruction Type			Storm Grate/Utility Type	
		N/A			N/A
			Yes	Surface Condition? (G/P)	Good

Remove & Replace Curb Ramp With Two New Directional Ramps or Equivalent.
