Access Compliance Report

Public Rights-of-Way

(Curb Ramps)

Intersection ID: 3906		Main Street: BROWNE'S_FERRY_RD		Cross Street: KIRKGARD_TL		Location: S													
ADA ID: 8015AAE6CAB1		Ramp Type: Directional1		Initial Pass/Fail: Fail		Overall Compliance: No		Severity Score: 8.75											
Codes/Mitigation Info/Possible Solution				Field Measurements/Component Compliance

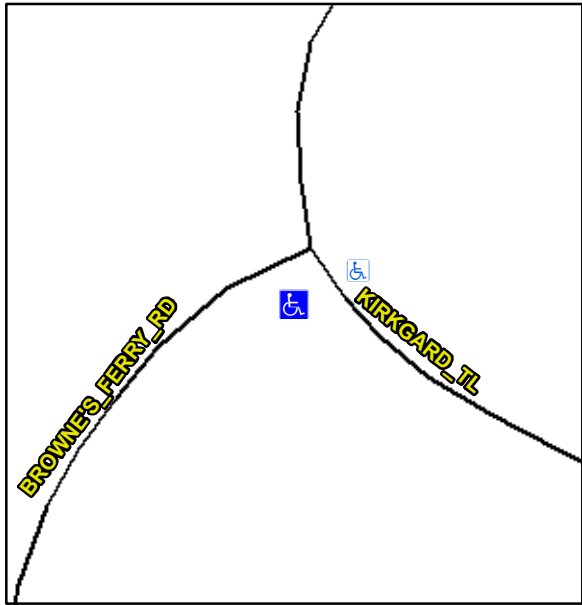
Possible Solutions:		Compliance		Description		Data		Compliance		Description		Data			
				Remove & Replace Entire Ramp.		N/A		N/A		Ramp Length (in)		47.0		N/A		Grade Break?		N/A	
Surveyor Notes:				N/A		N/A		No		Ramp Width (in)		45.5		N/A		Grade Break Slope (%)		0.0	
								Yes		Ramp Slope (%)		7.3		N/A		Grade Break XSlope (%)		0.0	
PROW/ADA:				R304.5.1		N/A		Yes		Ramp XSlope (%)		1.3		N/A		Flare Type RT		N/A	
								N/A		Flare Type LT		N/A		N/A		Flare Slope RT (%)		0.0	
Total Cost:				\$ 1600.00		N/A		N/A		Flare Slope LT (%)		N/A		N/A		Flare Traversable RT?		N/A

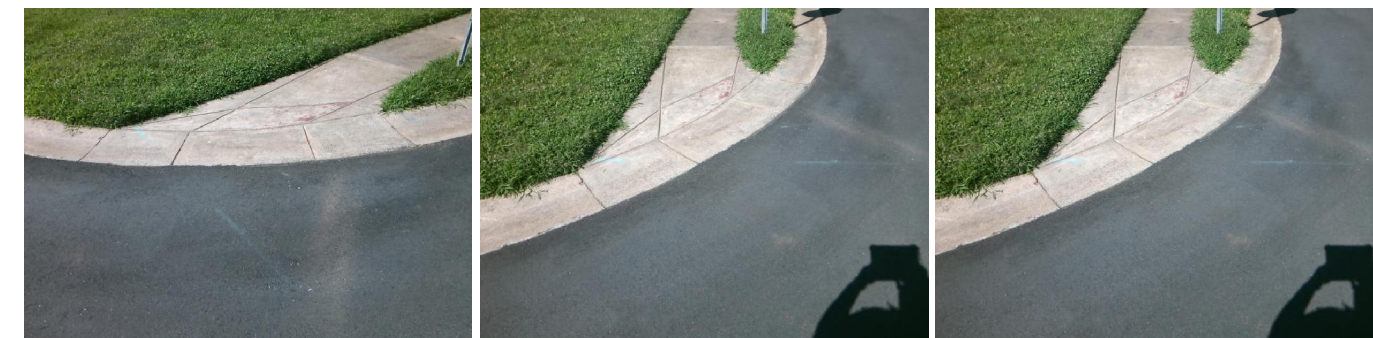
N/A		Ramp inside XWalk1?		N/A				Storm Grate/Utility Type			
						N/A		N/A		Any Obstructions?		N/A				N/A			
								N/A		Obstruction Type		Yes		Surface Condition? (G/P)		Good			
						N/A		N/A		N/A		N/A		Curb Slope (%)		7.5			
								N/A		N/A		N/A		N/A		N/A		N/A
