Access Compliance Report

Public Rights-of-Way

(Curb Ramps)

Intersection ID: 42365	Main Street: CARDINALS_NEST_DR	Cross Street: KESTRAL_RIDGE_DR	Location: SW
ADA ID: 8032B3AB94B5	Ramp Type: PerpDiag	Initial Pass/Fail: Fail	Overall Compliance: No
		Severity Score: 12.5

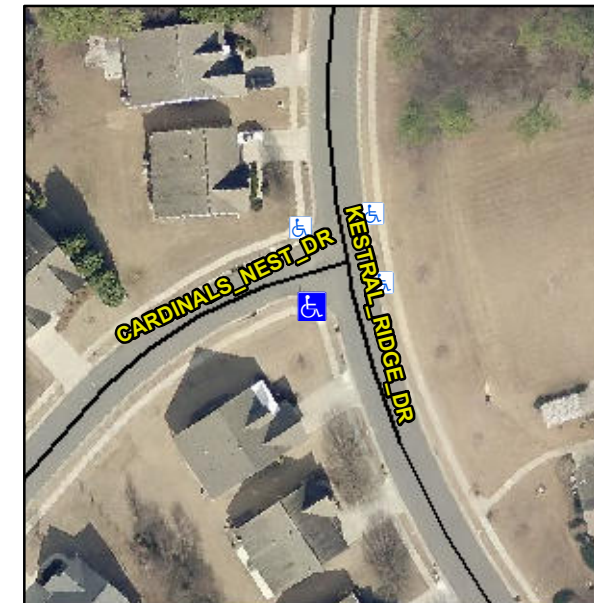
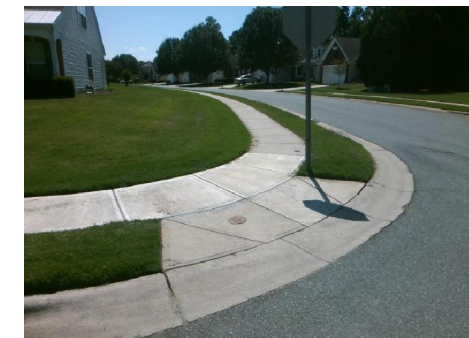
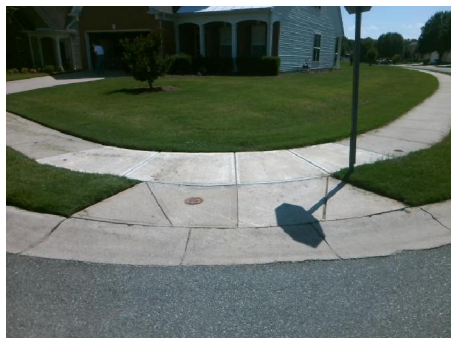
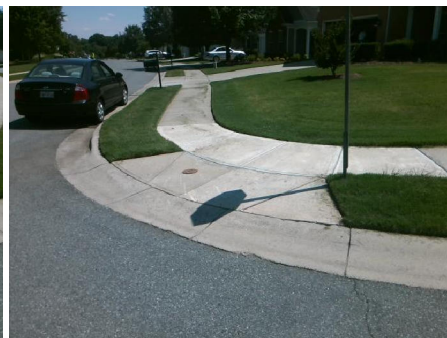
Not Found, R304.5.3

Compliance	Description	Data	Compliance	Description	Data
N/A	Ramp Length (in)	42.0	Yes	Ramp Slope (%)	6.5
Yes	Ramp Width (in)	58.0	No	Ramp XSlope (%)	5.2
N/A	Flare Type LT	N/A	N/A	Flare Type RT	N/A
N/A	Flare Slope LT (%)	N/A	N/A	Flare Slope RT (%)	N/A
N/A	Flare Traversable LT?	N/A	N/A	Flare Traversable RT?	N/A
N/A	Landing Length (in)	N/A	N/A	DWS Provided?	N/A
N/A	Landing Width (in)	N/A	N/A	DWS Contrast?	N/A
N/A	Landing Slope (%)	N/A	N/A	DWS Length (in)	N/A
N/A	Landing X Slope (%)	N/A	N/A	DWS Full Width?	N/A
N/A	Landing Curb? (Y/N)	N/A	N/A	DWS Offset (in)	N/A
N/A	Shared Landing?	N/A			
N/A	Gutter Ponding?	N/A	N/A	Gutter Slope (%)	N/A
N/A	Gutter Lip Ht (in)	N/A	N/A	Gutter X Slope (%)	N/A
N/A	Painted X Walk1?	No	N/A	Painted X Walk2?	No
	X Walk 1 Direction	To E		X Walk 2 Direction	To N
N/A	X Walk 1 Width (in)	N/A	N/A	X Walk 2 Width (in)	N/A
	X Walk 1 Slope (%)	2.3		X Walk 2 Slope (%)	1.4
	X Walk 1 X Slope (%)	1.2		X Walk 2 X Slope (%)	0.4

N/A	Ramp inside XWalk1?	N/A	N/A	Ramp inside XWalk2?	N/A
	Road Slope (%)	2.6	N/A	Clear Space?	N/A
	Road X Slope (%)	0.9	N/A	Clear Space to XWalk (in)	N/A
N/A	Any Obstructions?	N/A	N/A	Storm Grate/Utility Hazard?	N/A
	Obstruction Type			Storm Grate/Utility Type	
		N/A			N/A
		Yes		Surface Condition? (G/P)	Good

Remove & Replace Curb Ramp With Two New Directional Ramps or Equivalent.

Total Cost: \$ 3200.00
