Access Compliance Report Public Rights-of-Way (Curb Ramps)

Intersection ID: 10021826 Main Street: BRISTLE TOE LN **Cross Street: N/A** Location: SE ADA ID: 80371D7F7199 Ramp Type: PerpDiag Initial Pass/Fail: Fail **Overall Compliance: No** Severity Score: 13.75

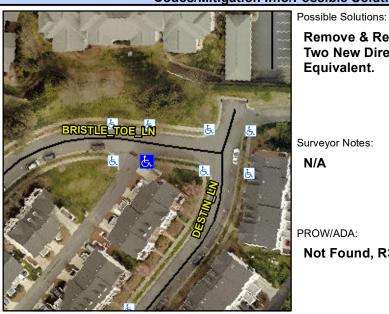
eyor Notes:		
A		
w/ADA:		
ot Found, R304.2.2, F	R304.5.3	
Cost:	\$	3200.00

Compliance Description Data			pliance Description	Data		
N	N/A	Ramp Length (in)	93.0	No	Ramp Slope (%)	11.7
Υ	⁄es	Ramp Width (in)	48.0	No	Ramp XSlope (%)	2.7
N	N/A	Flare Type LT	N/A	N/A	Flare Type RT	N/A
N	N/A	Flare Slope LT (%)	N/A	N/A	Flare Slope RT (%)	N/A
N	N/A	Flare Traversable LT?	N/A	N/A	Flare Traversable RT?	N/A
N	N/A	Landing Length (in)	N/A	N/A	DWS Provided?	N/A
N	N/A	Landing Width (in)	N/A	N/A	DWS Contrast?	N/A
N	N/A	Landing Slope (%)	N/A	N/A	DWS Length (in)	N/A
N	N/A	Landing X Slope (%)	N/A	N/A	DWS Full Width?	N/A
N	N/A	Landing Curb? (Y/N)	N/A	N/A	DWS Offset (in)	N/A
N	N/A	Shared Landing?	N/A			
N	N/A	Gutter Ponding?	N/A	N/A	Gutter Slope (%)	N/A
N	N/A	Gutter Lip Ht (in)	N/A	N/A	Gutter X Slope (%)	N/A
N	N/A	Painted X Walk1?	No	N/A	Painted X Walk2?	No
		X Walk 1 Direction	To NE		X Walk 2 Direction	To NW
N	N/A	X Walk 1 Width (in)	N/A	N/A	X Walk 2 Width (in)	N/A
		X Walk 1 Slope (%)	0.9		X Walk 2 Slope (%)	3.6

X Walk 1 X Slope (%)	3.7		X Walk 2 X Slope (%)	1.8
N	N/A	Ramp inside XWalk1?	N/A	N/A	Ramp inside XWalk2?	N/A
		Road Slope (%)	0.6	N/A	Clear Space?	N/A
		Road X Slope (%)	2.5	N/A	Clear Space to XWalk (in)	N/A
1	N/A	Any Obstructions?	N/A	N/A	Storm Grate/Utility Hazard?	N/A
		Obstruction Type			Storm Grate/Utility Type	
			N/A			N/A
				Yes	Surface Condition? (G/P)	Good
	TOTAL BUT	LAND A STREET,

Street 1 Name **BRISTLE TOE LN** Stop Condition-Street 2 None Street 2 Name N/A Stop Condition-Street 1 None **Remove & Replace Curb Ramp With Two New Directional Ramps or** Equivalent.
