Access Compliance Report

Public Rights-of-Way

(Curb Ramps)

Intersection ID: 12998	Main Street: 5TH_ST	Cross Street: MCDOWELL_ST	Location: S
ADA ID: 803CF6F96117	Ramp Type: Perp	Initial Pass/Fail: Fail	Overall Compliance: No
Severity Score: 13.75			
Codes/Mitigation Info/Possible Solution		Field Measurements/Component Compliance

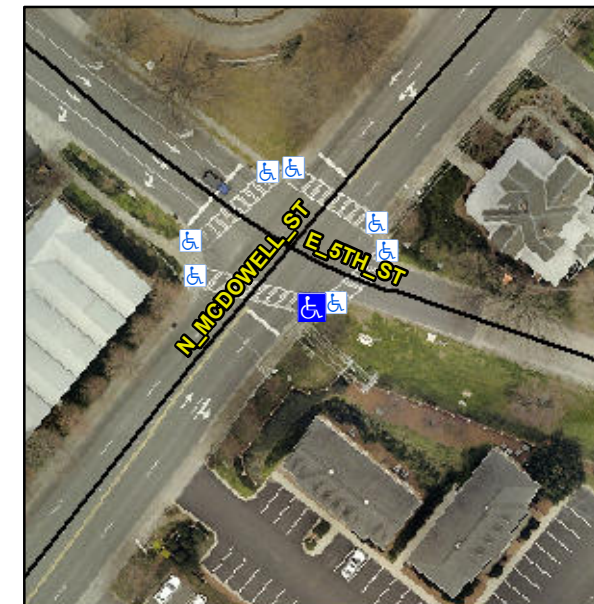
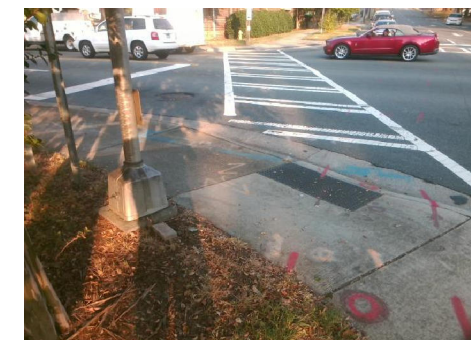
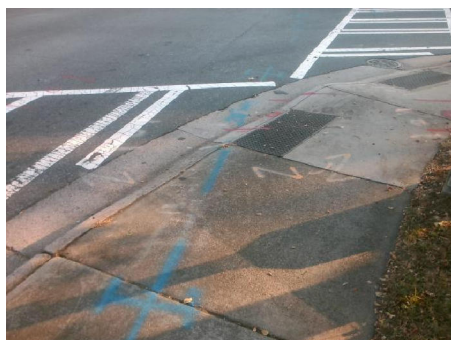
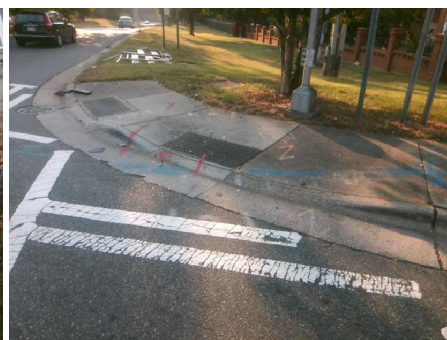
Not Found, R304.2.2, R304.5.3

Compliance	Description	Data	Compliance	Description	Data
N/A	Ramp Length (in)	71.0	No	Ramp Slope (%)	8.4
Yes	Ramp Width (in)	48.0	No	Ramp XSlope (%)	5.0
N/A	Flare Type LT	N/A	N/A	Flare Type RT	N/A
N/A	Flare Slope LT (%)	N/A	N/A	Flare Slope RT (%)	N/A
N/A	Flare Traversable LT?	N/A	N/A	Flare Traversable RT?	N/A
N/A	Landing Length (in)	N/A	N/A	DWS Provided?	N/A
N/A	Landing Width (in)	N/A	N/A	DWS Contrast?	N/A
N/A	Landing Slope (%)	N/A	N/A	DWS Length (in)	N/A
N/A	Landing X Slope (%)	N/A	N/A	DWS Full Width?	N/A
N/A	Landing Curb? (Y/N)	N/A	N/A	DWS Offset (in)	N/A
N/A	Shared Landing?	N/A			
N/A	Gutter Ponding?	N/A	N/A	Gutter Slope (%)	N/A
N/A	Gutter Lip Ht (in)	N/A	N/A	Gutter X Slope (%)	N/A
N/A	Painted X Walk1?	Yes	N/A	Painted X Walk2?	N/A
	X Walk 1 Direction	To NW		X Walk 2 Direction	N/A
N/A	X Walk 1 Width (in)	100.0	N/A	X Walk 2 Width (in)	N/A
	X Walk 1 Slope (%)	1.7		X Walk 2 Slope (%)	N/A
	X Walk 1 X Slope (%)	0.6		X Walk 2 X Slope (%)	N/A

N/A	Ramp inside XWalk1?	Yes	N/A	Ramp inside XWalk2?	N/A
	Road Slope (%)	N/A	N/A	Clear Space?	N/A
	Road X Slope (%)	N/A	N/A	Clear Space to XWalk (in)	N/A
N/A	Any Obstructions?	N/A	N/A	Storm Grate/Utility Hazard?	N/A
	Obstruction Type			Storm Grate/Utility Type	
		N/A			N/A
		Yes		Surface Condition? (G/P)	Good

Remove & Replace Entire Ramp.
