# Access Compliance Report

## Public Rights-of-Way

### (Curb Ramps)

Intersection ID: N/A	Main Street: BALLANTYNE_VILLAGE_WY	Cross Street: N/A	Location: NW
ADA ID: 806490C7814A	Ramp Type: PerpDiag	Initial Pass/Fail: Fail	Overall Compliance: No
Codes/Mitigation Info/Possible Solution		Field Measurements/Component Compliance

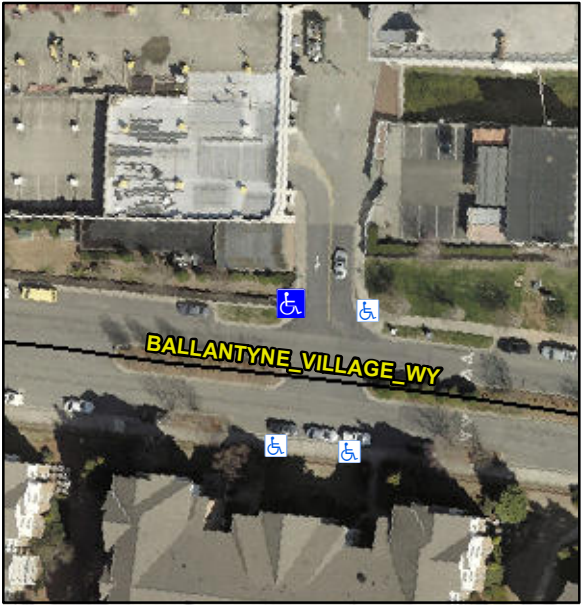
Possible Solutions:	Compliance	Description	Data	Compliance	Description	Data
	Remove & Replace Curb Ramp With Two New Directional Ramps or Equivalent.	N/A	Ramp Length (in)	62.0	No	Ramp Slope (%)	10.3
<p>Surveyor Notes:</p> <p>N/A</p> <p>PROW/ADA:</p> <p>Not Found, R304.5.1, R304.2.2, R304.5.3</p>		No	Ramp Width (in)	37.0	No	Ramp XSlope (%)	4.9
		N/A	Flare Type LT	N/A	N/A	Flare Type RT	N/A
		N/A	Flare Slope LT (%)	N/A	N/A	Flare Slope RT (%)	N/A
		N/A	Flare Traversable LT?	N/A	N/A	Flare Traversable RT?	N/A
		N/A	Landing Length (in)	N/A	N/A	DWS Provided?	N/A
		N/A	Landing Width (in)	N/A	N/A	DWS Contrast?	N/A
		N/A	Landing Slope (%)	N/A	N/A	DWS Length (in)	N/A
		N/A	Landing X Slope (%)	N/A	N/A	DWS Full Width?	N/A
		N/A	Landing Curb? (Y/N)	N/A	N/A	DWS Offset (in)	N/A
		N/A	Shared Landing?	N/A			
		N/A	Gutter Ponding?	N/A	N/A	Gutter Slope (%)	N/A
		N/A	Gutter Lip Ht (in)	N/A	N/A	Gutter X Slope (%)	N/A
		N/A	Painted X Walk1?	No	N/A	Painted X Walk2?	No

X Walk 1 Direction	To S		X Walk 2 Direction	To E
		N/A	X Walk 1 Width (in)	N/A	N/A	X Walk 2 Width (in)	N/A
			X Walk 1 Slope (%)	0.3		X Walk 2 Slope (%)	0.4
			X Walk 1 X Slope (%)	3.3		X Walk 2 X Slope (%)	5.1
		N/A	Ramp inside XWalk1?	N/A	N/A	Ramp inside XWalk2?	N/A
			Road Slope (%)	1.8	N/A	Clear Space?	N/A
			Road X Slope (%)	3.7	N/A	Clear Space to XWalk (in)	N/A
		N/A	Any Obstructions?	N/A	N/A	Storm Grate/Utility Hazard?	N/A
			Obstruction Type			Storm Grate/Utility Type	
					N/A		N/A
					Yes	Surface Condition? (G/P)	Good
