Access Compliance Report

Public Rights-of-Way

(Curb Ramps)

Intersection ID: 19959	Main Street: DEERFIELD_PL	Cross Street: WINTERCREST_LN	Location:	N
ADA ID: 8064B6742D4D	Ramp Type: Directional1	Initial Pass/Fail: Fail	Overall Compliance: No	Severity Score: 12.5

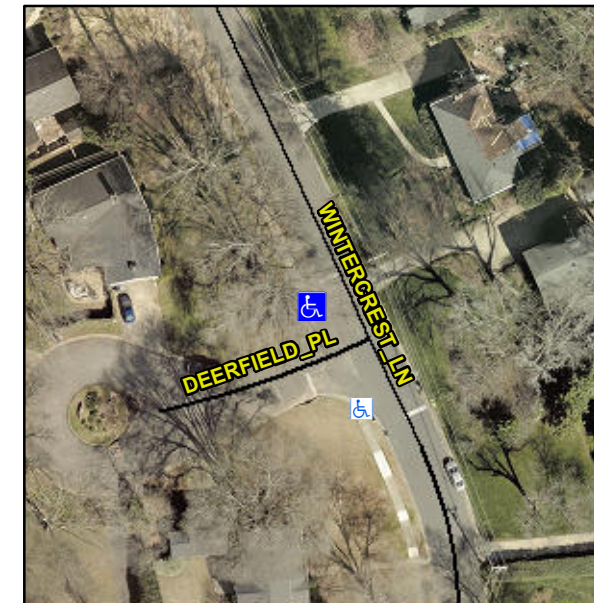
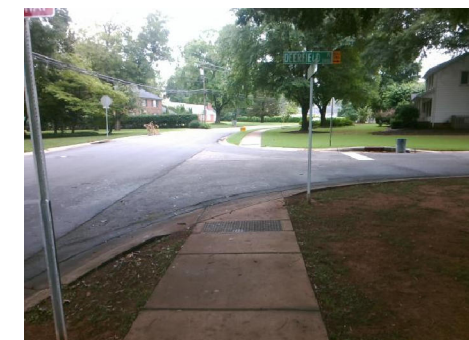
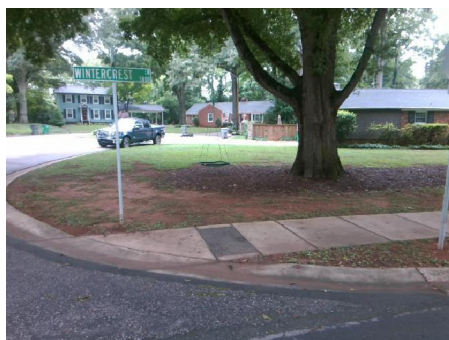
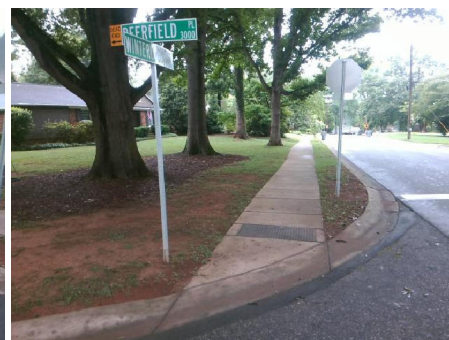
Compliance	Description	Data	Compliance	Description	Data
N/A	Ramp Length (in)	62.0	N/A	Grade Break?	N/A
Yes	Ramp Width (in)	61.0	N/A	Grade Break Slope (%)	0.0
Yes	Ramp Slope (%)	0.5	N/A	Grade Break XSlope (%)	0.0
No	Ramp XSlope (%)	5.8			
N/A	Flare Type LT	N/A	N/A	Flare Type RT	N/A
N/A	Flare Slope LT (%)	N/A	N/A	Flare Slope RT (%)	0.0
N/A	Flare Traversable LT?	N/A	N/A	Flare Traversable RT?	N/A
N/A	Landing Length (in)	0.0	N/A	DWS Provided?	N/A
N/A	Landing Width (in)	0.0	N/A	DWS Contrast?	N/A
N/A	Landing Slope (%)	0.0	N/A	DWS Length (in)	N/A
N/A	Landing X Slope (%)	0.0	N/A	DWS Full Width?	N/A
N/A	Landing Curb? (Y/N)	N/A	N/A	DWS Offset LT (in)	N/A
N/A	Shared Landing?	N/A	N/A	DWS Offset RT (in)	N/A
N/A	Gutter Ponding?	0.0	N/A	Gutter Slope (%)	N/A
N/A	Gutter Lip Ht (in)	0.0	N/A	Gutter X Slope (%)	N/A
N/A	Painted X Walk1?	No		Road Slope (%)	4.2
	X Walk 1 Direction	To SE		Road X Slope (%)	1.6
	X Walk 1 Width (in)	N/A		Clear Space?	N/A

X Walk 1 Slope (%)	4.2	N/A	Clear Space to XWalk (in)	N/A
	X Walk 1 X Slope (%)	1.6	N/A	Storm Grate/Utility Hazard?	N/A
N/A	Ramp inside XWalk1?	N/A		Storm Grate/Utility Type	
N/A	Any Obstructions?	N/A			N/A
	Obstruction Type		Yes	Surface Condition? (G/P)	Good
			N/A	Curb Slope (%)	2.6

Remove & Replace Entire Ramp.
