Intersection ID: 12445	Main Street: CHESTNUT_AV	Cross Street: THE_PLAZA	Location:	SW
ADA ID: 8078BD7EAE75	Ramp Type: Perp	Initial Pass/Fail: Fail	Overall Compliance: No	Severity Score: 21.25

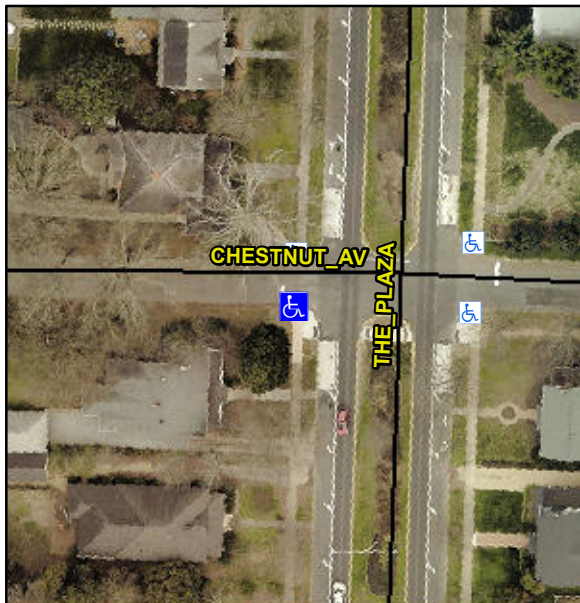
Possible Solutions:		Compliance	Description	Data	Compliance	Description	Data
	Remove & Replace Entire Ramp.		N/A	Ramp Length (in)	52.0	No	Ramp Slope (%)	9.0
			No	Ramp Width (in)	40.0	Yes	Ramp XSlope (%)	0.3
			N/A	Flare Type LT	N/A	N/A	Flare Type RT	N/A
			N/A	Flare Slope LT (%)	N/A	N/A	Flare Slope RT (%)	N/A
			N/A	Flare Traversable LT?	N/A	N/A	Flare Traversable RT?	N/A
			N/A	Landing Length (in)	N/A	N/A	DWS Provided?	N/A
			N/A	Landing Width (in)	N/A	N/A	DWS Contrast?	N/A
			N/A	Landing Slope (%)	N/A	N/A	DWS Length (in)	N/A
			N/A	Landing X Slope (%)	N/A	N/A	DWS Full Width?	N/A
Surveyor Notes:		N/A	N/A	Landing Curb? (Y/N)	N/A	N/A	DWS Offset (in)	N/A
PROW/ADA:		R304.5.1, R304.2.2	N/A	Shared Landing?	N/A	N/A		
			N/A	Gutter Ponding?	N/A	N/A	Gutter Slope (%)	N/A
			N/A	Gutter Lip Ht (in)	N/A	N/A	Gutter X Slope (%)	N/A

N/A	Painted X Walk1?	No	N/A	Painted X Walk2?	N/A
				X Walk 1 Direction	To N		X Walk 2 Direction	N/A
			N/A	X Walk 1 Width (in)	N/A	N/A	X Walk 2 Width (in)	N/A
				X Walk 1 Slope (%)	0.4		X Walk 2 Slope (%)	N/A
				X Walk 1 X Slope (%)	2.4		X Walk 2 X Slope (%)	N/A
Street 1 Name		CHESTNUT AV	N/A	Ramp inside XWalk1?	N/A	N/A	Ramp inside XWalk2?	N/A
Stop Condition-Street 2		StopSign		Road Slope (%)	N/A	N/A	Clear Space?	N/A
Street 2 Name		N/A		Road X Slope (%)	N/A	N/A	Clear Space to XWalk (in)	N/A
Stop Condition-Street 1		N/A	N/A	Any Obstructions?	N/A	N/A	Storm Grate/Utility Hazard?	N/A
				Obstruction Type			Storm Grate/Utility Type	
Total Cost:		\$ 1850.00			N/A			N/A
						Yes	Surface Condition? (G/P)	Good
