Access Compliance Report

Public Rights-of-Way

(Curb Ramps)

Intersection ID: 29381	Main Street: GLENDYNE_DR	Cross Street: PLEASANT_DALE_DR	Location: W
ADA ID: 807BA37BC61A	Ramp Type: PerpDiag	Initial Pass/Fail: Fail	Overall Compliance: No
Severity Score: 22.5			
Codes/Mitigation Info/Possible Solution		Field Measurements/Component Compliance

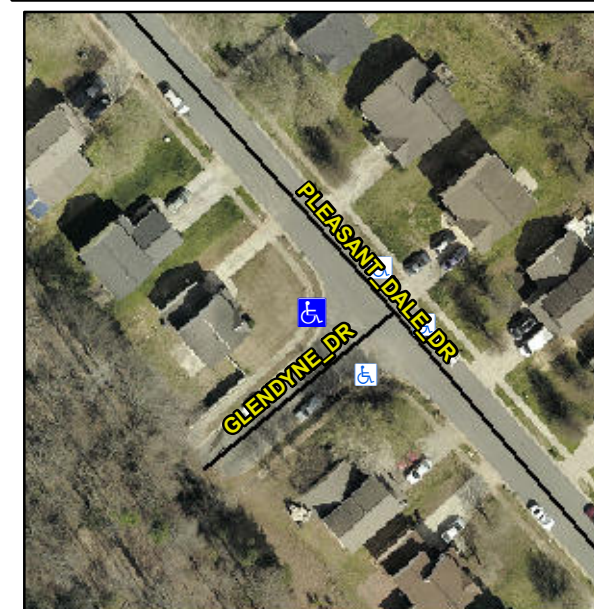
Not Found, R304.5.1, R304.2.2, R304.5.3

Compliance	Description	Data	Compliance	Description	Data
N/A	Ramp Length (in)	47.0	No	Ramp Slope (%)	8.4
No	Ramp Width (in)	42.0	No	Ramp XSlope (%)	2.9
N/A	Flare Type LT	N/A	N/A	Flare Type RT	N/A
N/A	Flare Slope LT (%)	N/A	N/A	Flare Slope RT (%)	N/A
N/A	Flare Traversable LT?	N/A	N/A	Flare Traversable RT?	N/A
N/A	Landing Length (in)	N/A	N/A	DWS Provided?	N/A
N/A	Landing Width (in)	N/A	N/A	DWS Contrast?	N/A
N/A	Landing Slope (%)	N/A	N/A	DWS Length (in)	N/A
N/A	Landing X Slope (%)	N/A	N/A	DWS Full Width?	N/A
N/A	Landing Curb? (Y/N)	N/A	N/A	DWS Offset (in)	N/A
N/A	Shared Landing?	N/A			
N/A	Gutter Ponding?	N/A	N/A	Gutter Slope (%)	N/A
N/A	Gutter Lip Ht (in)	N/A	N/A	Gutter X Slope (%)	N/A
N/A	Painted X Walk1?	No	N/A	Painted X Walk2?	No
	X Walk 1 Direction	To SE		X Walk 2 Direction	To NE
N/A	X Walk 1 Width (in)	N/A	N/A	X Walk 2 Width (in)	N/A
	X Walk 1 Slope (%)	3.1		X Walk 2 Slope (%)	2.0
	X Walk 1 X Slope (%)	0.7		X Walk 2 X Slope (%)	1.9

N/A	Ramp inside XWalk1?	N/A	N/A	Ramp inside XWalk2?	N/A
	Road Slope (%)	1.8	N/A	Clear Space?	N/A
	Road X Slope (%)	0.8	N/A	Clear Space to XWalk (in)	N/A
N/A	Any Obstructions?	N/A	N/A	Storm Grate/Utility Hazard?	N/A
	Obstruction Type			Storm Grate/Utility Type	
		N/A			N/A
			Yes	Surface Condition? (G/P)	Good

Possible Solutions:

Remove & Replace Curb Ramp With Two New Directional Ramps or Equivalent.
