Access Compliance Report

Public Rights-of-Way

(Curb Ramps)

Intersection ID: 53746	Main Street: SPRINGWOOD_ESTATE_DR	Cross Street: CANTERBURY_CASTLE_DR	Location: NW
ADA ID: 80841AA5FDB8	Ramp Type: BlendTrans1	Initial Pass/Fail: Fail	Overall Compliance: No
Severity Score: 8.75			
Codes/Mitigation Info/Possible Solution		Field Measurements/Component Compliance

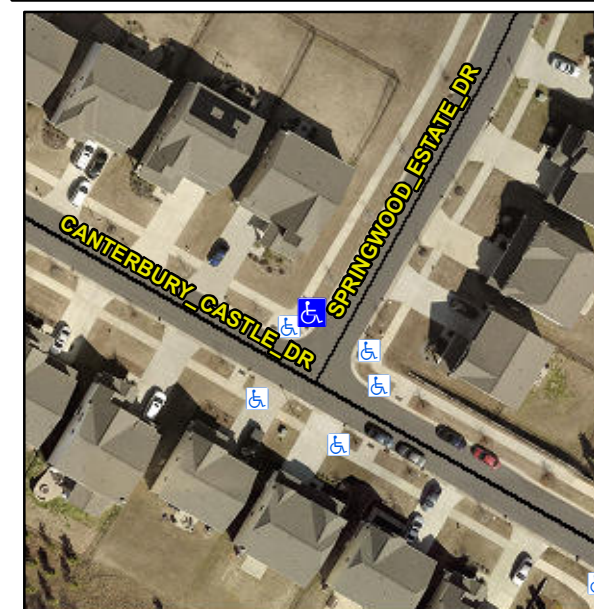
Not Found, R304.5.1

Compliance	Description	Data	Compliance	Description	Data
N/A	Ramp Length (in)	101.0	Yes	BlendTrans Slope (%)	0.7
No	Ramp Width (in)	41.5	Yes	BlendTrans XSlope (%)	1.8
N/A	Flare Type LT	N/A	N/A	Flare Type RT	N/A
N/A	Flare Slope LT (%)	N/A	N/A	Flare Slope RT (%)	N/A
N/A	Flare Traversable LT?	N/A	N/A	Flare Traversable RT?	N/A
N/A	Landing Length (in)	N/A	N/A	DWS Provided?	N/A
N/A	Landing Width (in)	N/A	N/A	DWS Contrast?	N/A
N/A	Landing Slope (%)	N/A	N/A	DWS Length (in)	N/A
N/A	Landing X Slope (%)	N/A	N/A	DWS Full Width?	N/A
N/A	Landing Curb? (Y/N)	N/A	N/A	DWS Offset (in)	N/A
N/A	Shared Landing?	N/A			
N/A	Gutter Ponding?	N/A	N/A	Gutter Slope (%)	N/A
N/A	Gutter Lip Ht (in)	N/A	N/A	Gutter X Slope (%)	N/A
N/A	Painted X Walk1?	No	N/A	Painted X Walk2?	N/A
	X Walk 1 Direction	To SE		X Walk 2 Direction	N/A
	X Walk 1 Width (in)	N/A		X Walk 2 Width (in)	N/A
	X Walk 1 Slope (%)	3.8		X Walk 2 Slope (%)	N/A
	X Walk 1 X Slope (%)	4.4		X Walk 2 X Slope (%)	N/A

N/A	Ramp inside XWalk1?	N/A	N/A	Ramp inside XWalk2?	N/A
	Road Slope (%)	4.4		Clear Space?	N/A
	Road X Slope (%)	3.8	N/A	Clear Space to XWalk (in)	N/A
N/A	Any Obstructions?	N/A	N/A	Storm Grate/Utility Hazard?	N/A
	Obstruction Type			Storm Grate/Utility Type	
		N/A			N/A
			Yes	Surface Condition? (G/P)	Good
			No	Curb Slope (%)	6.6

Possible Solutions:

Remove & Replace Curb Ramp With Two New Directional Ramps or Equivalent.
