Access Compliance Report

Public Rights-of-Way

(Curb Ramps)

| Intersection ID: 10031794 | Main Street: MILL_RIVER_LN | Cross Street: N/A | Location: NW |

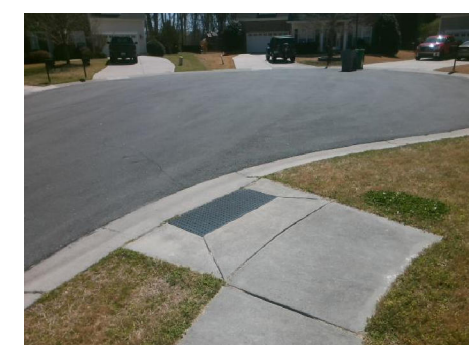
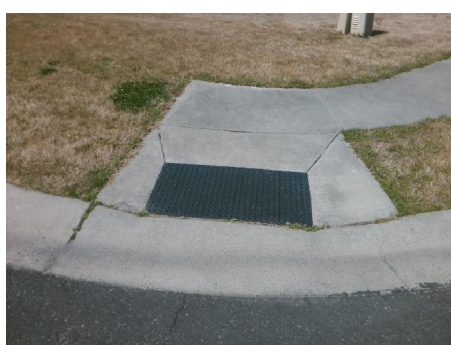
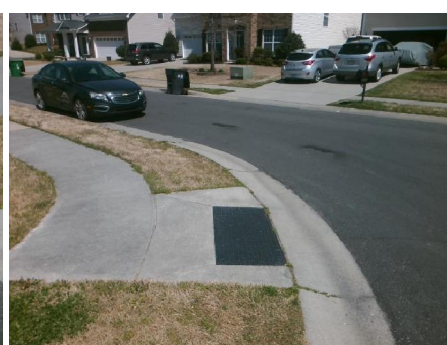
| ADA ID: 80A57DA6302D | Ramp Type: Perp | Initial Pass/Fail: Fail | Overall Compliance: No |
| Severity Score: 12.5 | | | |

R304.2.2

| Compliance | Description | Data | Compliance | Description | Data |
|---|---|---|---|---|---|
| N/A | Ramp Length (in) | 48.0 | No | Ramp Slope (%) | 10.2 |

Remove & Replace Entire Ramp.

\$ 1850.00
