# Access Compliance Report

## Public Rights-of-Way

### (Curb Ramps)

Intersection ID: 26693	Main Street: CANFIELD_HILL_CT	Cross Street: WINTHROP_RIDGE_RD	Location: SW
ADA ID: 80CDE440D632	Ramp Type: BlendTrans1	Initial Pass/Fail: Fail	Overall Compliance: No
Severity Score: 8.75			
Codes/Mitigation Info/Possible Solution		Field Measurements/Component Compliance

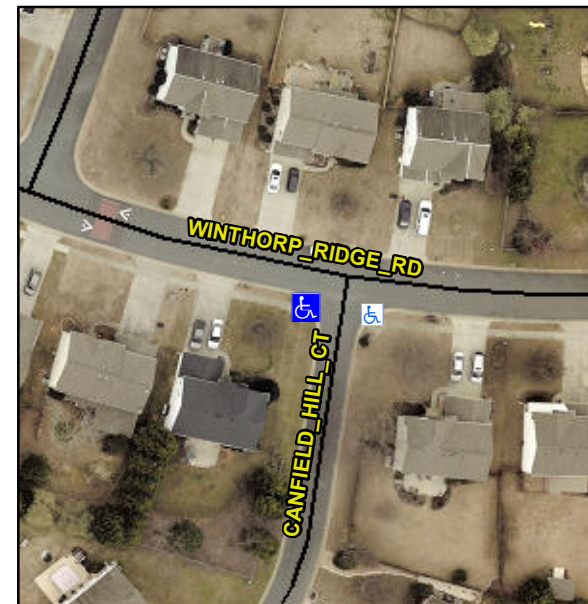
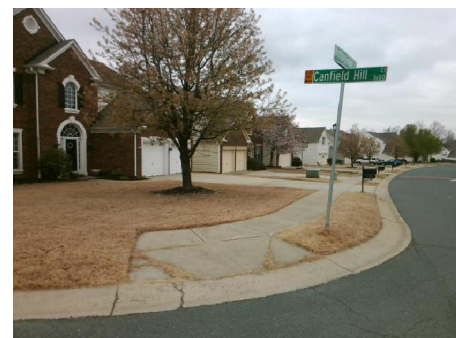
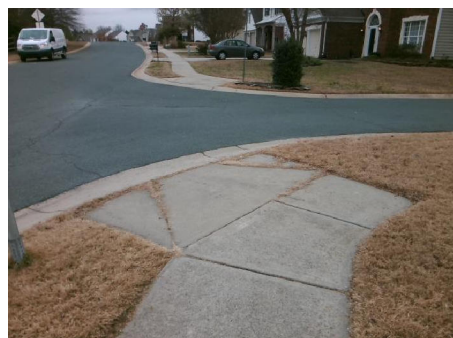
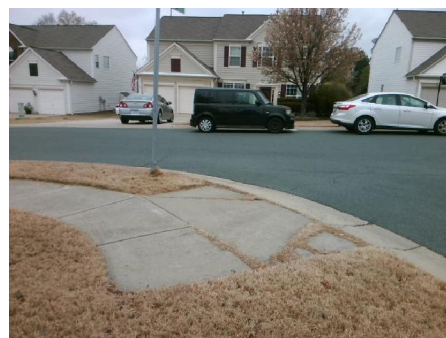
**Not Found, R304.5.1**

Compliance	Description	Data	Compliance	Description	Data
N/A	Ramp Length (in)	57.0	Yes	BlendTrans Slope (%)	3.0
No	Ramp Width (in)	41.0	Yes	BlendTrans XSlope (%)	0.2
N/A	Flare Type LT	N/A	N/A	Flare Type RT	N/A
N/A	Flare Slope LT (%)	N/A	N/A	Flare Slope RT (%)	N/A
N/A	Flare Traversable LT?	N/A	N/A	Flare Traversable RT?	N/A
N/A	Landing Length (in)	N/A	N/A	DWS Provided?	N/A
N/A	Landing Width (in)	N/A	N/A	DWS Contrast?	N/A
N/A	Landing Slope (%)	N/A	N/A	DWS Length (in)	N/A
N/A	Landing X Slope (%)	N/A	N/A	DWS Full Width?	N/A
N/A	Landing Curb? (Y/N)	N/A	N/A	DWS Offset (in)	N/A
N/A	Shared Landing?	N/A			
N/A	Gutter Ponding?	N/A	N/A	Gutter Slope (%)	N/A
N/A	Gutter Lip Ht (in)	N/A	N/A	Gutter X Slope (%)	N/A
N/A	Painted X Walk1?	No	N/A	Painted X Walk2?	N/A
	X Walk 1 Direction	To E		X Walk 2 Direction	N/A
	X Walk 1 Width (in)	N/A		X Walk 2 Width (in)	N/A
	X Walk 1 Slope (%)	3.6		X Walk 2 Slope (%)	N/A
	X Walk 1 X Slope (%)	1.1		X Walk 2 X Slope (%)	N/A

N/A	Ramp inside XWalk1?	N/A	N/A	Ramp inside XWalk2?	N/A
	Road Slope (%)	1.1		Clear Space?	N/A
	Road X Slope (%)	3.6	N/A	Clear Space to XWalk (in)	N/A
N/A	Any Obstructions?	N/A	N/A	Storm Grate/Utility Hazard?	N/A
	Obstruction Type			Storm Grate/Utility Type	
		N/A			N/A
			Yes	Surface Condition? (G/P)	Good
			No	Curb Slope (%)	13.9

**Remove & Replace Curb Ramp With Two New Directional Ramps or Equivalent.**
