Access Compliance Report

Public Rights-of-Way

(Curb Ramps)

Intersection ID: 15435	Main Street: LATTIMORE_ST	Cross Street: SCOTT_AV	Location:	E
ADA ID: 80D369F23CBF	Ramp Type: Directional1	Initial Pass/Fail: Fail	Overall Compliance: No	Severity Score: 10

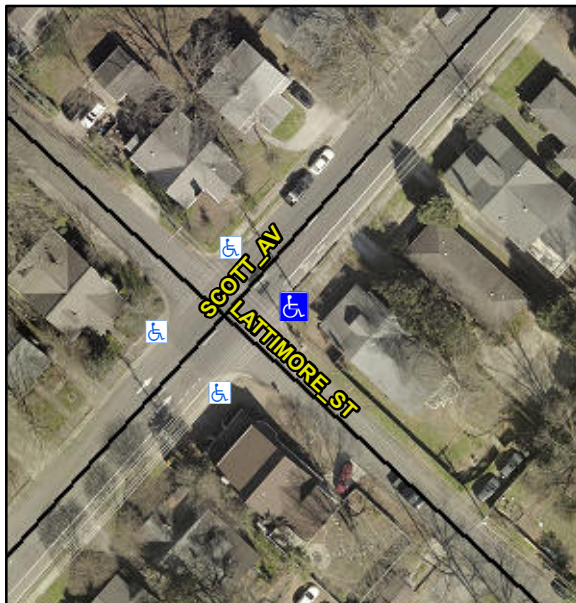
Compliance	Description	Data	Compliance	Description	Data
N/A	Ramp Length (in)	62.0	N/A	Grade Break?	N/A
No	Ramp Width (in)	38.5	N/A	Grade Break Slope (%)	0.0
Yes	Ramp Slope (%)	3.3	N/A	Grade Break XSlope (%)	0.0
No	Ramp XSlope (%)	4.7			
N/A	Flare Type LT	N/A	N/A	Flare Type RT	N/A
N/A	Flare Slope LT (%)	N/A	N/A	Flare Slope RT (%)	0.0
N/A	Flare Traversable LT?	N/A	N/A	Flare Traversable RT?	N/A
N/A	Landing Length (in)	0.0	N/A	DWS Provided?	N/A
N/A	Landing Width (in)	0.0	N/A	DWS Contrast?	N/A
N/A	Landing Slope (%)	0.0	N/A	DWS Length (in)	N/A
N/A	Landing X Slope (%)	0.0	N/A	DWS Full Width?	N/A
N/A	Landing Curb? (Y/N)	N/A	N/A	DWS Offset LT (in)	N/A
N/A	Shared Landing?	N/A	N/A	DWS Offset RT (in)	N/A
N/A	Gutter Ponding?	0.0	N/A	Gutter Slope (%)	N/A
N/A	Gutter Lip Ht (in)	0.0	N/A	Gutter X Slope (%)	N/A
N/A	Painted X Walk1?	No		Road Slope (%)	2.2
	X Walk 1 Direction	To SW		Road X Slope (%)	1.0
	X Walk 1 Width (in)	N/A		Clear Space?	N/A

X Walk 1 Slope (%)	2.2	N/A	Clear Space to XWalk (in)	N/A
	X Walk 1 X Slope (%)	1.0	N/A	Storm Grate/Utility Hazard?	N/A
N/A	Ramp inside XWalk1?	N/A		Storm Grate/Utility Type	
N/A	Any Obstructions?	N/A			N/A
	Obstruction Type		Yes	Surface Condition? (G/P)	Good
			N/A	Curb Slope (%)	4.1

Possible Solutions:

Remove & Replace Entire Ramp.
