Intersection ID: 14704	Main Street: BELGRAVE_PL	Cross Street: ROMANY_RD	Location:	SW
ADA ID: 80D8A1A559B5	Ramp Type: Para	Initial Pass/Fail: Pass	Overall Compliance: No	Severity Score: 0

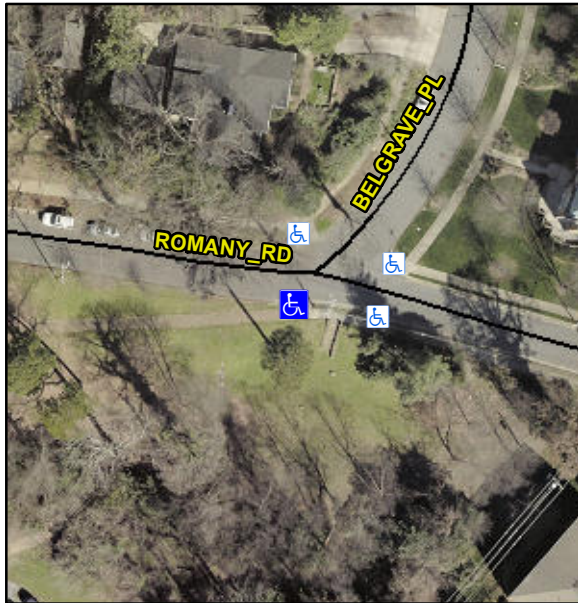
CURB GAP 1.5

Possible Solutions:			Compliance	Description	Data	Compliance	Description	Data
Remove & Replace Entire Ramp.	N/A	Ramp Length LT (in)	72.0	N/A	Ramp Length RT (in)	72.0		
	Yes	Ramp Width LT (in)	88.0	Yes	Ramp Width RT (in)	92.0		
	Yes	Ramp Slope LT (%)	7.5	Yes	Ramp Slope RT (%)	7.6		
	Yes	Ramp XSlope LT (%)	0.5	Yes	Ramp XSlope RT (%)	0.4		
	Yes	Landing Length (in)	88.0	Yes	DWS Provided?	Yes		
	Yes	Landing Width (in)	48.0	Yes	DWS Contrast?	Yes		
	Yes	Landing Slope (%)	0.5	Yes	DWS Length (in)	24.0		
	Yes	Landing X Slope (%)	0.1	Yes	DWS Full Width?	Yes		
	N/A	Landing Curb? (Y/N)	No	Yes	DWS Offset (in)	1.5		
	N/A	Shared Landing?	No					
Surveyor Notes:	Yes	Gutter Ponding?	No	Yes	Gutter Slope (%)	3.7		
	Yes	Gutter Lip Ht (in)	0.0	Yes	Gutter X Slope (%)	0.9		
	N/A	Painted X Walk1?	No	N/A	Painted X Walk2?	N/A		
		X Walk 1 Direction	To N		X Walk 2 Direction	N/A		
	N/A	X Walk 1 Width (in)	N/A	N/A	X Walk 2 Width (in)	N/A

X Walk 1 Slope (%)	5.5		X Walk 2 Slope (%)	N/A		
		X Walk 1 X Slope (%)	1.3		X Walk 2 X Slope (%)	N/A		
	N/A	Ramp inside XWalk1?	N/A	N/A	Ramp inside XWalk2?	N/A		
		Road Slope (%)	N/A	N/A	Clear Space?	Yes		
		Road X Slope (%)	N/A	N/A	Clear Space to XWalk (in)	N/A		
CURB GAP 1.5	Yes	Any Obstructions?	No	Yes	Storm Grate/Utility Hazard?	No		
		Obstruction Type			Storm Grate/Utility Type			
PROW/ADA:								
Not Found								
Total Cost:		\$	1600.00					
				N/A				N/A
				Yes	Surface Condition? (G/P)	Good		
				Replace	Curb Slope (%)	14.2

Remove & Replace Entire Ramp.
