# Access Compliance Report

## Public Rights-of-Way

### (Curb Ramps)

Intersection ID: 14272	Main Street: BROOKHILL_RD	Cross Street: VILLAGE_CT	Location: NW
ADA ID: 80DB384D4716	Ramp Type: PerpDiag	Initial Pass/Fail: Fail	Overall Compliance: No
Severity Score: 13.75			
Codes/Mitigation Info/Possible Solution		Field Measurements/Component Compliance

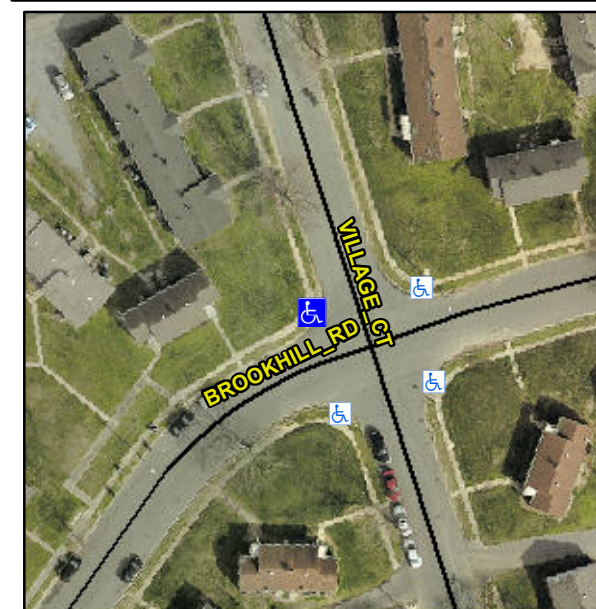
**N/A**

**Not Found, R304.2.2, R304.5.3**

Compliance	Description	Data	Compliance	Description	Data
N/A	Ramp Length (in)	92.0	No	Ramp Slope (%)	11.9
Yes	Ramp Width (in)	48.0	No	Ramp XSlope (%)	4.3
N/A	Flare Type LT	N/A	N/A	Flare Type RT	N/A
N/A	Flare Slope LT (%)	N/A	N/A	Flare Slope RT (%)	N/A
N/A	Flare Traversable LT?	N/A	N/A	Flare Traversable RT?	N/A
N/A	Landing Length (in)	N/A	N/A	DWS Provided?	N/A
N/A	Landing Width (in)	N/A	N/A	DWS Contrast?	N/A
N/A	Landing Slope (%)	N/A	N/A	DWS Length (in)	N/A
N/A	Landing X Slope (%)	N/A	N/A	DWS Full Width?	N/A
N/A	Landing Curb? (Y/N)	N/A	N/A	DWS Offset (in)	N/A
N/A	Shared Landing?	N/A			
N/A	Gutter Ponding?	N/A	N/A	Gutter Slope (%)	N/A
N/A	Gutter Lip Ht (in)	N/A	N/A	Gutter X Slope (%)	N/A
N/A	Painted X Walk1?	No	N/A	Painted X Walk2?	No
	X Walk 1 Direction	To S		X Walk 2 Direction	To E
N/A	X Walk 1 Width (in)	N/A	N/A	X Walk 2 Width (in)	N/A
	X Walk 1 Slope (%)	7.5		X Walk 2 Slope (%)	0.1
	X Walk 1 X Slope (%)	0.6		X Walk 2 X Slope (%)	7.0

N/A	Ramp inside XWalk1?	N/A	N/A	Ramp inside XWalk2?	N/A
	Road Slope (%)	6.5	N/A	Clear Space?	N/A
	Road X Slope (%)	8.2	N/A	Clear Space to XWalk (in)	N/A
N/A	Any Obstructions?	N/A	N/A	Storm Grate/Utility Hazard?	N/A
	Obstruction Type			Storm Grate/Utility Type	
		N/A			N/A
		Yes		Surface Condition? (G/P)	Good

**Remove & Replace Curb Ramp With Two New Directional Ramps or Equivalent.**

Total Cost: \$ 3200.00
