Access Compliance Report

Public Rights-of-Way

(Curb Ramps)

Intersection ID: 3125	Main Street: JOHNSTON_OEHLER_RD	Cross Street: MOURNING_DOVE_LN	Location: SE
ADA ID: 80F27BEE99E1	Ramp Type: Combination1	Initial Pass/Fail: Fail	Overall Compliance: No
		Severity Score: 12.5

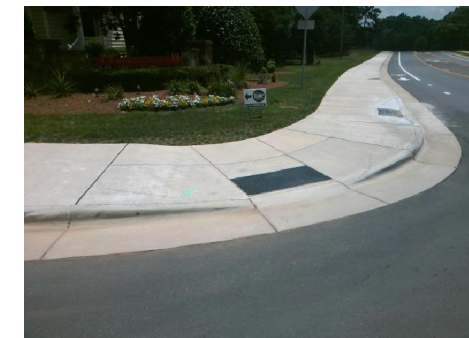
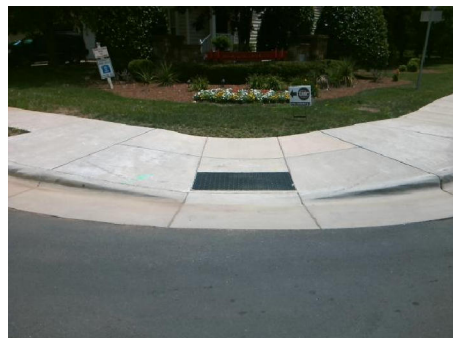
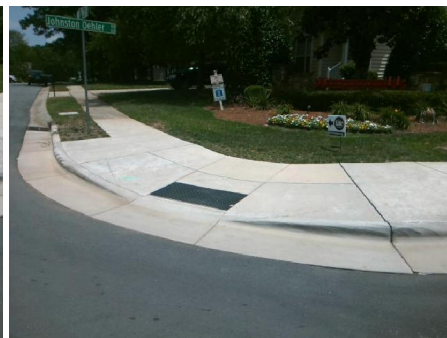
RT RP < 5%

Not Found, R304.2.2, R304.3.2

Compliance	Description	Data	Compliance	Description	Data
N/A	Ramp Length LT (in)	38.0	N/A	Ramp Length RT (in)	31.0
Yes	Ramp Width LT (in)	90.0	Yes	Ramp Width RT (in)	90.0
No	Ramp Slope LT (%)	9.4	Yes	Ramp Slope RT (%)	4.1
Yes	Ramp XSlope LT (%)	0.3	Yes	Ramp XSlope RT (%)	1.2
N/A	Ramp Length (in)	90.0	No	Ramp Slope (%)	10.2
Yes	Ramp Width (in)	48.0	Yes	Ramp XSlope (%)	0.4
N/A	Flare Type LT	N/A	N/A	Flare Type RT	N/A
N/A	Flare Slope LT (%)	N/A	N/A	Flare Slope RT (%)	N/A
N/A	Flare Traversable LT?	N/A	N/A	Flare Traversable RT?	N/A
N/A	Landing Length (in)	N/A	N/A	DWS Provided?	N/A
N/A	Landing Width (in)	N/A	N/A	DWS Contrast?	N/A
N/A	Landing Slope (%)	N/A	N/A	DWS Length (in)	N/A
N/A	Landing X Slope (%)	N/A	N/A	DWS Full Width?	N/A
N/A	Landing Curb? (Y/N)	N/A	N/A	DWS Offset (in)	N/A
N/A	Shared Landing?	N/A			
N/A	Gutter Ponding?	N/A	N/A	Gutter Slope (%)	N/A
N/A	Gutter Lip Ht (in)	N/A	N/A	Gutter X Slope (%)	N/A
N/A	Painted X Walk1?	No	N/A	Painted X Walk2?	N/A

X Walk 1 Direction	To N		X Walk 2 Direction	N/A
	X Walk 1 Width (in)	N/A		X Walk 2 Width (in)	N/A
	X Walk 1 Slope (%)	4.1		X Walk 2 Slope (%)	N/A
	X Walk 1 X Slope (%)	1.2		X Walk 2 X Slope (%)	N/A
N/A	Ramp inside XWalk1?	N/A	N/A	Ramp inside XWalk2?	N/A
	Road Slope (%)	N/A		Clear Space?	N/A
	Road X Slope (%)	N/A	N/A	Clear Space to XWalk (in)	N/A
			N/A	Any Obstruction?	N/A
				Obstruction Type	N/A
			N/A	Storm Grate/Utility Hazard?	N/A
				Storm Grate/Utility Type	N/A
Yes	Surface Condition? (G/P)	Good			
	Curb Slope (%)	10.6

Remove & Replace Entire Ramp.

Total Cost: \$ 1800.00
