# Access Compliance Report

## Public Rights-of-Way

### (Curb Ramps)

Intersection ID: 11363	Main Street: N_POPLAR_ST	Cross Street: W_12TH_ST	Location: N
ADA ID: 80FAEBCFEFAA	Ramp Type: Perp	Initial Pass/Fail: Fail	Overall Compliance: No
			Severity Score: 33.75

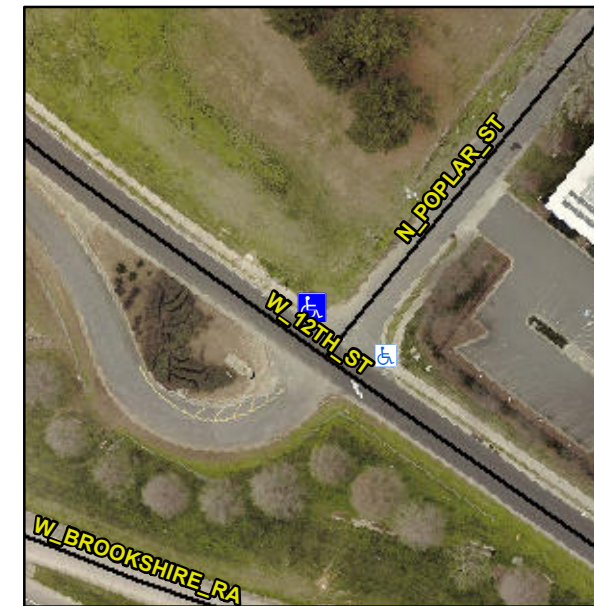
**Not Found, R304.5.1, R304.2.2, R304.5.3**

Compliance	Description	Data	Compliance	Description	Data
N/A	Ramp Length (in)	35.0	No	Ramp Slope (%)	9.5
No	Ramp Width (in)	40.0	No	Ramp XSlope (%)	6.1
N/A	Flare Type LT	N/A	N/A	Flare Type RT	N/A
N/A	Flare Slope LT (%)	N/A	N/A	Flare Slope RT (%)	N/A
N/A	Flare Traversable LT?	N/A	N/A	Flare Traversable RT?	N/A
N/A	Landing Length (in)	N/A	N/A	DWS Provided?	N/A
N/A	Landing Width (in)	N/A	N/A	DWS Contrast?	N/A
N/A	Landing Slope (%)	N/A	N/A	DWS Length (in)	N/A
N/A	Landing X Slope (%)	N/A	N/A	DWS Full Width?	N/A
N/A	Landing Curb? (Y/N)	N/A	N/A	DWS Offset (in)	N/A
N/A	Shared Landing?	N/A			
N/A	Gutter Ponding?	N/A	N/A	Gutter Slope (%)	N/A
N/A	Gutter Lip Ht (in)	1.0	N/A	Gutter X Slope (%)	N/A
N/A	Painted X Walk1?	No	N/A	Painted X Walk2?	N/A
	X Walk 1 Direction	To SE		X Walk 2 Direction	N/A
N/A	X Walk 1 Width (in)	N/A	N/A	X Walk 2 Width (in)	N/A
	X Walk 1 Slope (%)	2.7		X Walk 2 Slope (%)	N/A
	X Walk 1 X Slope (%)	2.9		X Walk 2 X Slope (%)	N/A

N/A	Ramp inside XWalk1?	N/A	N/A	Ramp inside XWalk2?	N/A
	Road Slope (%)	N/A	N/A	Clear Space?	N/A
	Road X Slope (%)	N/A	N/A	Clear Space to XWalk (in)	N/A
N/A	Any Obstructions?	N/A	N/A	Storm Grate/Utility Hazard?	N/A
	Obstruction Type			Storm Grate/Utility Type	
		N/A			N/A
			Yes	Surface Condition? (G/P)	Good

**Remove & Replace Entire Ramp.**
