# Access Compliance Report

## Public Rights-of-Way

| Intersection ID: 31705 | Main Street: ATLAS_CEDAR_DR | Cross Street: CARPENTARIA_CT | Location: SW |
| ADA ID: 811AF990C7BB | Ramp Type: PerpDiag | Initial Pass/Fail: Fail | Overall Compliance: No |

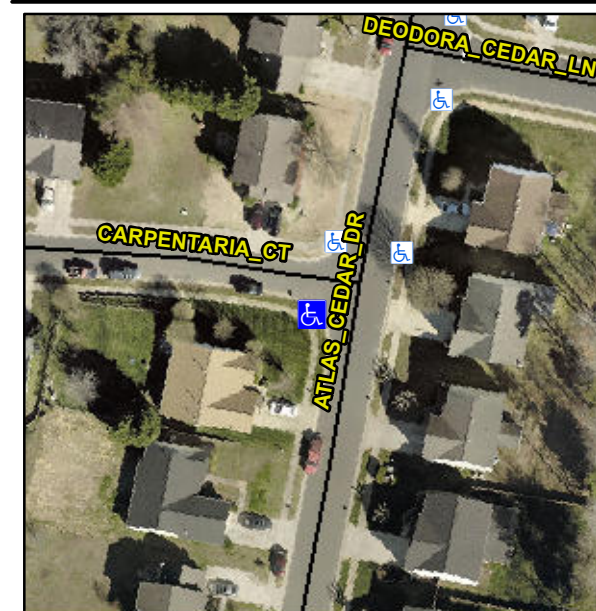
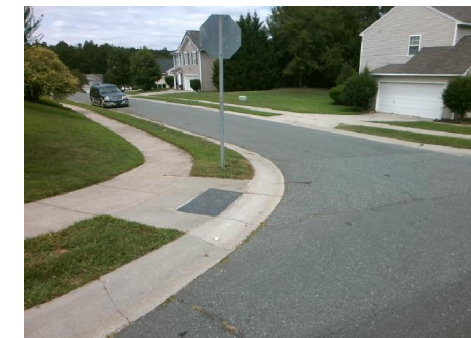
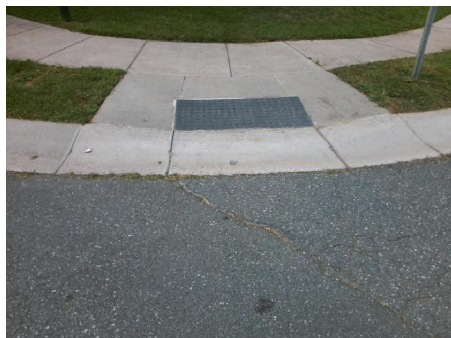
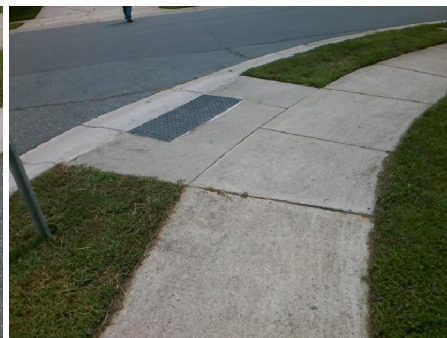
| | | | Severity Score: 21.25 |

**Not Found, R304.5.1, R304.5.3**

| Compliance | Description | Data | Compliance | Description | Data |
|---|---|---|---|---|---|
| N/A | Ramp Length (in) | 48.0 | Yes | Ramp Slope (%) | 5.0 |
| No | Ramp Width (in) | 39.5 | No | Ramp XSlope (%) | 6.8 |

**Remove & Replace Curb Ramp With Two New Directional Ramps or Equivalent.**

Total Cost: \$ 3200.00
