Access Compliance Report

Public Rights-of-Way (Curb Ramps)

Intersection ID: 24330	Main Street: CHINA GROVE CHURCH RD	Cross Street: PACKARD ST	Location: NE
ADA ID: 8123D7A90B04	Ramp Type: PerpDiag	Initial Pass/Fail: Fail	Overall Compliance: No
Severity Score: 22.5			
Codes/Mitigation Info/Possible Solution		Field Measurements/Component Compliance

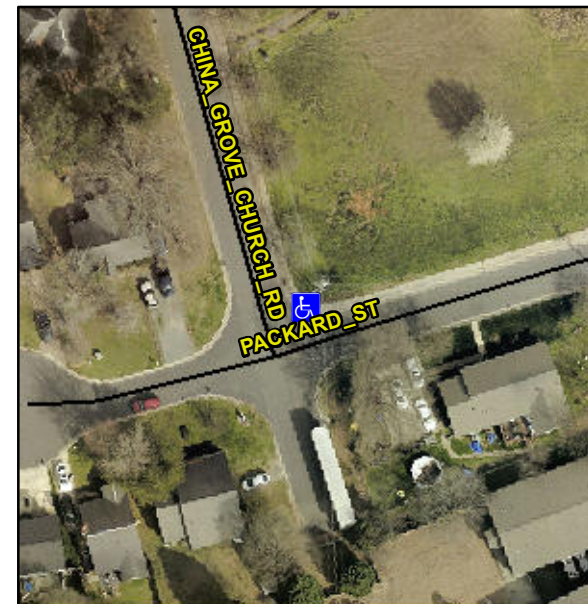
Not Found, R304.5.1, R304.2.2, R304.5.3

Compliance	Description	Data	Compliance	Description	Data
N/A	Ramp Length (in)	53.0	No	Ramp Slope (%)	9.2
No	Ramp Width (in)	36.0	No	Ramp XSlope (%)	4.3
N/A	Flare Type LT	N/A	N/A	Flare Type RT	N/A
N/A	Flare Slope LT (%)	N/A	N/A	Flare Slope RT (%)	N/A
N/A	Flare Traversable LT?	N/A	N/A	Flare Traversable RT?	N/A
N/A	Landing Length (in)	N/A	N/A	DWS Provided?	N/A
N/A	Landing Width (in)	N/A	N/A	DWS Contrast?	N/A
N/A	Landing Slope (%)	N/A	N/A	DWS Length (in)	N/A
N/A	Landing X Slope (%)	N/A	N/A	DWS Full Width?	N/A
N/A	Landing Curb? (Y/N)	N/A	N/A	DWS Offset (in)	N/A
N/A	Shared Landing?	N/A			
N/A	Gutter Ponding?	N/A	N/A	Gutter Slope (%)	N/A
N/A	Gutter Lip Ht (in)	N/A	N/A	Gutter X Slope (%)	N/A
N/A	Painted X Walk1?	No	N/A	Painted X Walk2?	No
	X Walk 1 Direction	To W		X Walk 2 Direction	To S
N/A	X Walk 1 Width (in)	N/A	N/A	X Walk 2 Width (in)	N/A
	X Walk 1 Slope (%)	2.2		X Walk 2 Slope (%)	1.5
	X Walk 1 X Slope (%)	1.2		X Walk 2 X Slope (%)	4.1

N/A	Ramp inside XWalk1?	N/A	N/A	Ramp inside XWalk2?	N/A
	Road Slope (%)	3.9	N/A	Clear Space?	N/A
	Road X Slope (%)	3.5	N/A	Clear Space to XWalk (in)	N/A
N/A	Any Obstructions?	N/A	N/A	Storm Grate/Utility Hazard?	N/A
	Obstruction Type			Storm Grate/Utility Type	
		N/A			N/A
			Yes	Surface Condition? (G/P)	Good

Remove & Replace Curb Ramp With Two New Directional Ramps or Equivalent.
