Access Compliance Report Public Rights-of-Way (Curb Ramps)

Intersection ID: 46315 Main Street: TYVOLA_RD Cross Street: MARGELLINA_DR Location: E

ADA ID: 812C4F8FA405 Ramp Type: PerpDiag Initial Pass/Fail: Fail Overall Compliance: No Severity Score: 12.5

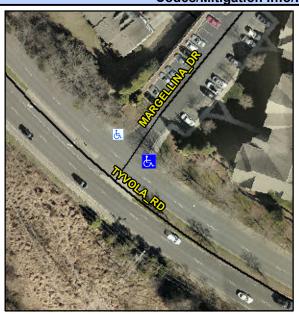
Field Measurements/Component Compnance						
Compliance Description		Data	Compl	iance	Description	Data
N/A	Ramp Length (in)	59.0	Yes	Ramp	Slope (%)	7.5
Yes	Ramp Width (in)	49.0	No	Ramp	XSlope (%)	5.1
N/A	Flare Type LT	N/A	N/A	Flare	Type RT	N/A
N/A	Flare Slope LT (%)	N/A	N/A	Flare	Slope RT (%)	N/A
N/A	Flare Traversable LT?	N/A	N/A	Flare	Traversable RT?	N/A
N/A	Landing Length (in)	N/A	N/A	DWS	Provided?	N/A
N/A	Landing Width (in)	N/A	N/A	DWS	Contrast?	N/A
N/A	Landing Slope (%)	N/A	N/A	DWS	Length (in)	N/A
N/A	Landing X Slope (%)	N/A	N/A	DWS	Full Width?	N/A
N/A	Landing Curb? (Y/N)	N/A	N/A	DWS	Offset (in)	N/A
N/A	Shared Landing?	N/A				
N/A	Gutter Ponding?	N/A	N/A	Gutte	r Slope (%)	N/A
N/A	Gutter Lip Ht (in)	N/A	N/A	Gutte	r X Slope (%)	N/A
N/A	Painted X Walk1?	No	N/A	Painte	ed X Walk2?	No
	X Walk 1 Direction	To NW		X Wal	k 2 Direction	To SW
N/A	X Walk 1 Width (in)	N/A	N/A	X Wal	k 2 Width (in)	N/A
	X Walk 1 Slope (%)	4.0		X Wal	k 2 Slope (%)	12.2

X Walk 1 X Slope (%)	1.4		X Wal	k 2 X Slope (%)	5.0
N/A	Ramp inside XWalk1?	N/A	N/A	Ramp	inside XWalk2?	N/A
	Road Slope (%)	3.7	N/A	Clear	Space?	N/A
	Road X Slope (%)	1.7	N/A	Clear	Space to XWalk (in)	N/A
N/A	Any Obstructions?	N/A	N/A	Storm	Grate/Utility Hazard?	N/A
	Obstruction Type			Storm	Grate/Utility Type

MAEGELLINA DR StopSign TYVOLA RD None Possible Solutions:

Remove & Replace Curb Ramp With Two New Directional Ramps or Equivalent.
