Access Compliance Report

Public Rights-of-Way

(Curb Ramps)

Intersection ID: 15377	Main Street: ELMHURST_RD	Cross Street: HAVERFORD_PL	Location:	N
ADA ID: 812EFBEB5DB8	Ramp Type: Directional1	Initial Pass/Fail: Fail	Overall Compliance: No	Severity Score: 1.25
Codes/Mitigation Info/Possible Solution		Field Measurements/Component Compliance

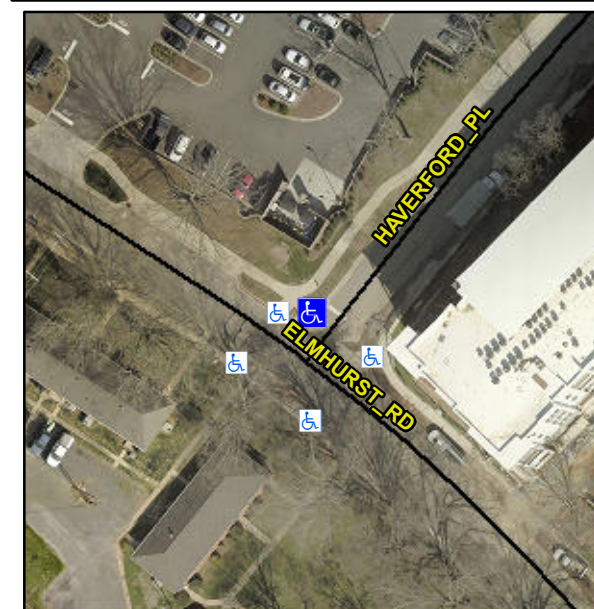
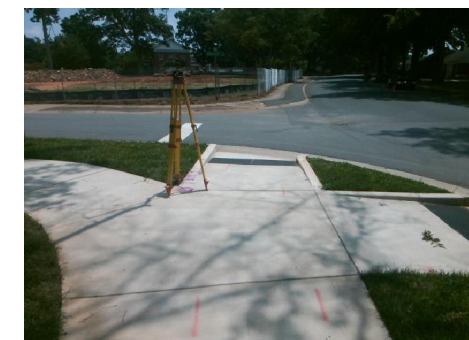
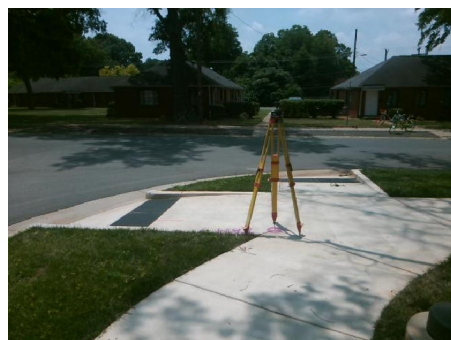
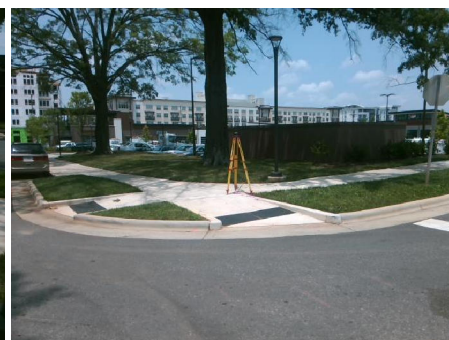
Compliance	Description	Data	Compliance	Description	Data
N/A	Ramp Length (in)	92.0	N/A	Grade Break?	N/A
Yes	Ramp Width (in)	68.5	N/A	Grade Break Slope (%)	0.0
Yes	Ramp Slope (%)	5.8	N/A	Grade Break XSlope (%)	0.0
No	Ramp XSlope (%)	2.4			
N/A	Flare Type LT	N/A	N/A	Flare Type RT	N/A
N/A	Flare Slope LT (%)	N/A	N/A	Flare Slope RT (%)	0.0
N/A	Flare Traversable LT?	N/A	N/A	Flare Traversable RT?	N/A
N/A	Landing Length (in)	0.0	N/A	DWS Provided?	N/A
N/A	Landing Width (in)	0.0	N/A	DWS Contrast?	N/A
N/A	Landing Slope (%)	0.0	N/A	DWS Length (in)	N/A
N/A	Landing X Slope (%)	0.0	N/A	DWS Full Width?	N/A
N/A	Landing Curb? (Y/N)	N/A	N/A	DWS Offset LT (in)	N/A
N/A	Shared Landing?	N/A	N/A	DWS Offset RT (in)	N/A
N/A	Gutter Ponding?	0.0	N/A	Gutter Slope (%)	N/A
N/A	Gutter Lip Ht (in)	0.0	N/A	Gutter X Slope (%)	N/A
N/A	Painted X Walk1?	No		Road Slope (%)	1.3
	X Walk 1 Direction	To SE		Road X Slope (%)	2.0
	X Walk 1 Width (in)	N/A		Clear Space?	N/A

X Walk 1 Slope (%)	1.3	N/A	Clear Space to XWalk (in)	N/A
	X Walk 1 X Slope (%)	2.0	N/A	Storm Grate/Utility Hazard?	N/A
N/A	Ramp inside XWalk1?	N/A		Storm Grate/Utility Type	
N/A	Any Obstructions?	N/A			N/A
	Obstruction Type		Yes	Surface Condition? (G/P)	Good
			N/A	Curb Slope (%)	3.4

Possible Solutions:

Remove & Replace Entire Ramp.

R304.5.3

\$ 1600.00
