# Access Compliance Report

## Public Rights-of-Way

### (Curb Ramps)

Intersection ID: N/A	Main Street: GROVER_RD	Cross Street: N/A	Location: NE
ADA ID: 812F5190B9B6	Ramp Type: PerpDiag	Initial Pass/Fail: Fail	Overall Compliance: No
		Severity Score: 12.5

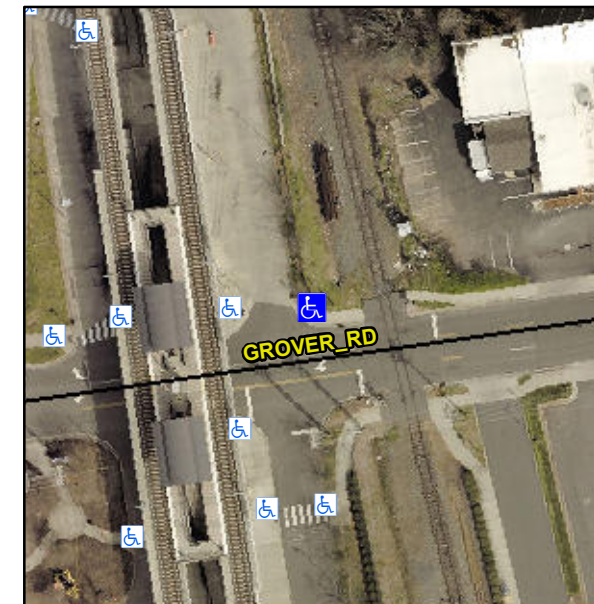
**Not Found, R304.5.3**

Compliance	Description	Data	Compliance	Description	Data
N/A	Ramp Length (in)	39.0	Yes	Ramp Slope (%)	6.4
Yes	Ramp Width (in)	48.0	No	Ramp XSlope (%)	5.1
N/A	Flare Type LT	N/A	N/A	Flare Type RT	N/A
N/A	Flare Slope LT (%)	N/A	N/A	Flare Slope RT (%)	N/A
N/A	Flare Traversable LT?	N/A	N/A	Flare Traversable RT?	N/A
N/A	Landing Length (in)	N/A	N/A	DWS Provided?	N/A
N/A	Landing Width (in)	N/A	N/A	DWS Contrast?	N/A
N/A	Landing Slope (%)	N/A	N/A	DWS Length (in)	N/A
N/A	Landing X Slope (%)	N/A	N/A	DWS Full Width?	N/A
N/A	Landing Curb? (Y/N)	N/A	N/A	DWS Offset (in)	N/A
N/A	Shared Landing?	N/A			
N/A	Gutter Ponding?	N/A	N/A	Gutter Slope (%)	N/A
N/A	Gutter Lip Ht (in)	N/A	N/A	Gutter X Slope (%)	N/A
N/A	Painted X Walk1?	No	N/A	Painted X Walk2?	No
	X Walk 1 Direction	To W		X Walk 2 Direction	To S
N/A	X Walk 1 Width (in)	N/A	N/A	X Walk 2 Width (in)	N/A
	X Walk 1 Slope (%)	5.5		X Walk 2 Slope (%)	2.8
	X Walk 1 X Slope (%)	2.1		X Walk 2 X Slope (%)	6.2

N/A	Ramp inside XWalk1?	N/A	N/A	Ramp inside XWalk2?	N/A
	Road Slope (%)	6.3	N/A	Clear Space?	N/A
	Road X Slope (%)	1.9	N/A	Clear Space to XWalk (in)	N/A
N/A	Any Obstructions?	N/A	N/A	Storm Grate/Utility Hazard?	N/A
	Obstruction Type			Storm Grate/Utility Type	
		N/A			N/A
		Yes		Surface Condition? (G/P)	Good

**Remove & Replace Curb Ramp With Two New Directional Ramps or Equivalent.**

Total Cost: \$ 3200.00
