Intersection ID: 10032566		Main Street: N_GRAHAM_ST		Cross Street: N/A		Location:		N									
ADA ID: 8133046D69C9		Ramp Type: Directional2		Initial Pass/Fail: Fail		Overall Compliance: No		Severity Score: 13.75									
Codes/Mitigation Info/Possible Solution				Field Measurements/Component Compliance

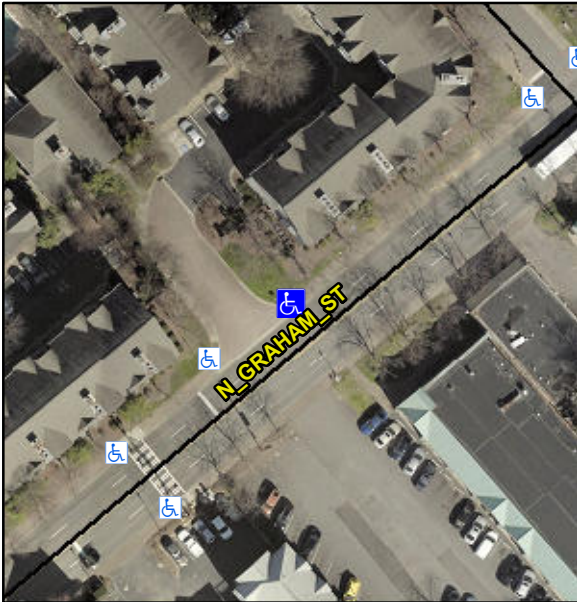
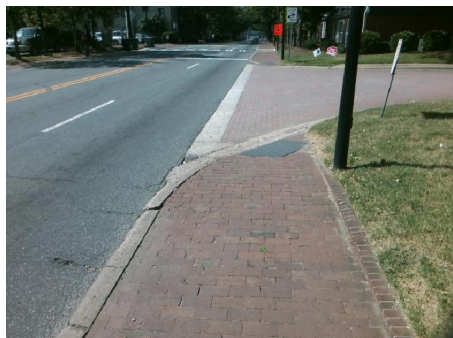
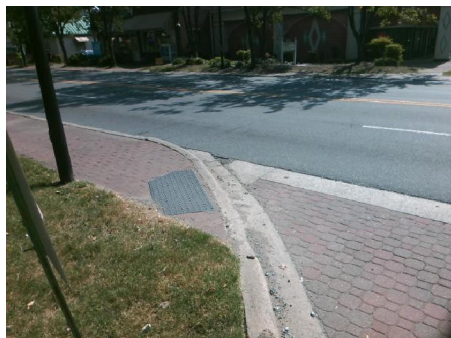
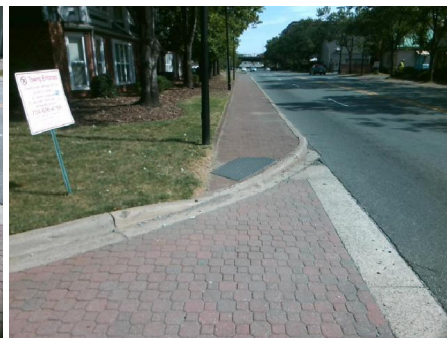
Possible Solutions:		Compliance		Description		Data		Compliance		Description		Data	
				Remove & Replace Entire Ramp.		N/A		Ramp Length (in)		62.0		N/A		Grade Break?		N/A	
				Surveyor Notes:		Yes		Ramp Width (in)		60.0		N/A		Grade Break Slope (%)		0.0	
				N/A		No		Ramp Slope (%)		10.2		N/A		Grade Break XSlope (%)		0.0	
				PROW/ADA:		No		Ramp XSlope (%)		3.6							
				R304.2.2, R304.5.3		N/A		Flare Type LT		N/A		N/A		Flare Type RT		N/A	
						N/A		Flare Slope LT (%)		N/A		N/A		Flare Slope RT (%)		0.0	
						N/A		Flare Traversable LT?		N/A		N/A		Flare Traversable RT?		N/A	
						N/A		Landing Length (in)		0.0		N/A		DWS Provided?		N/A

N/A		Landing Width (in)		0.0		N/A		DWS Contrast?		N/A	
						N/A		Landing Slope (%)		0.0		N/A		DWS Length (in)		N/A	
						N/A		Landing X Slope (%)		0.0		N/A		DWS Full Width?		N/A	
						N/A		Landing Curb? (Y/N)		N/A		N/A		DWS Offset LT (in)		N/A	
						N/A		Shared Landing?		N/A		N/A		DWS Offset RT (in)		N/A	
						N/A		Gutter Ponding?		0.0		N/A		Gutter Slope (%)		N/A	
						N/A		Gutter Lip Ht (in)		0.0		N/A		Gutter X Slope (%)		N/A	
						N/A		Painted X Walk1?		No				Road Slope (%)		1.1	
								X Walk 1 Direction		To SW				Road X Slope (%)		0.5	
								X Walk 1 Width (in)		N/A				Clear Space?		N/A	
								X Walk 1 Slope (%)		1.1		N/A		Clear Space to XWalk (in)		N/A	
								X Walk 1 X Slope (%)		0.5		N/A		Storm Grate/Utility Hazard?		N/A	
						N/A		Ramp inside XWalk1?		N/A				Storm Grate/Utility Type			
						N/A		Any Obstructions?		N/A						N/A	
								Obstruction Type				Yes		Surface Condition? (G/P)		Good

Total Cost:		\$		1800.00		N/A		N/A		Curb Slope (%)		8.5
