Access Compliance Report

Public Rights-of-Way

(Curb Ramps)

Intersection ID: 30489	Main Street: BEDDINGFIELD_DR	Cross Street: STONES_LANDING_ST	Location: SW
ADA ID: 8147DFA637AB	Ramp Type: PerpDiag	Initial Pass/Fail: Fail	Overall Compliance: No
Severity Score: 22.5			
Codes/Mitigation Info/Possible Solution		Field Measurements/Component Compliance

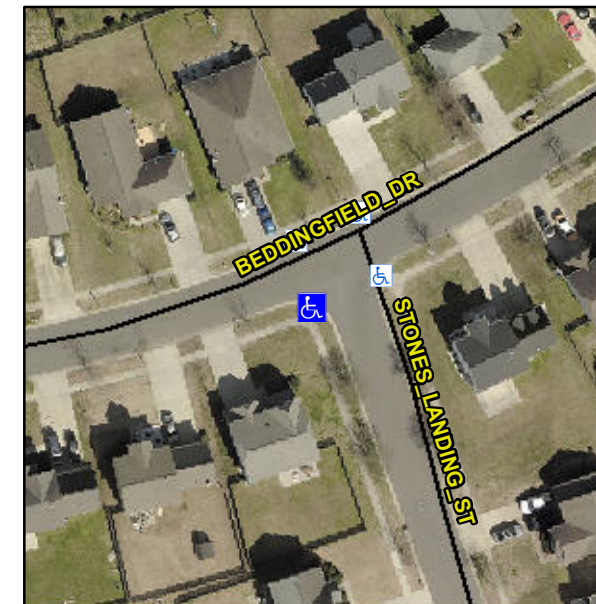
Compliance	Description	Data	Compliance	Description	Data
N/A	Ramp Length (in)	85.0	No	Ramp Slope (%)	9.7
No	Ramp Width (in)	42.0	No	Ramp XSlope (%)	2.3
N/A	Flare Type LT	N/A	N/A	Flare Type RT	N/A
N/A	Flare Slope LT (%)	N/A	N/A	Flare Slope RT (%)	N/A
N/A	Flare Traversable LT?	N/A	N/A	Flare Traversable RT?	N/A
N/A	Landing Length (in)	N/A	N/A	DWS Provided?	N/A
N/A	Landing Width (in)	N/A	N/A	DWS Contrast?	N/A
N/A	Landing Slope (%)	N/A	N/A	DWS Length (in)	N/A
N/A	Landing X Slope (%)	N/A	N/A	DWS Full Width?	N/A
N/A	Landing Curb? (Y/N)	N/A	N/A	DWS Offset (in)	N/A
N/A	Shared Landing?	N/A			
N/A	Gutter Ponding?	N/A	N/A	Gutter Slope (%)	N/A
N/A	Gutter Lip Ht (in)	N/A	N/A	Gutter X Slope (%)	N/A
N/A	Painted X Walk1?	No	N/A	Painted X Walk2?	No
	X Walk 1 Direction	To E		X Walk 2 Direction	To N
N/A	X Walk 1 Width (in)	N/A	N/A	X Walk 2 Width (in)	N/A
	X Walk 1 Slope (%)	0.8		X Walk 2 Slope (%)	4.5
	X Walk 1 X Slope (%)	2.2		X Walk 2 X Slope (%)	0.8

N/A	Ramp inside XWalk1?	N/A	N/A	Ramp inside XWalk2?	N/A
	Road Slope (%)	0.6	N/A	Clear Space?	N/A
	Road X Slope (%)	2.8	N/A	Clear Space to XWalk (in)	N/A
N/A	Any Obstructions?	N/A	N/A	Storm Grate/Utility Hazard?	N/A
	Obstruction Type			Storm Grate/Utility Type	
		N/A			N/A
			Yes	Surface Condition? (G/P)	Good

Possible Solutions:

Remove & Replace Curb Ramp With Two New Directional Ramps or Equivalent.

PROW/ADA:

R304.5.1, R304.2.2, R304.5.3
