Intersection ID: 15684	Main Street: NORTON_RD	Cross Street: S_KINGS_DR	Location:	SE
ADA ID: 814D23D3AD78	Ramp Type: PerpDiag	Initial Pass/Fail: Fail	Overall Compliance: No	Severity Score: 13.75

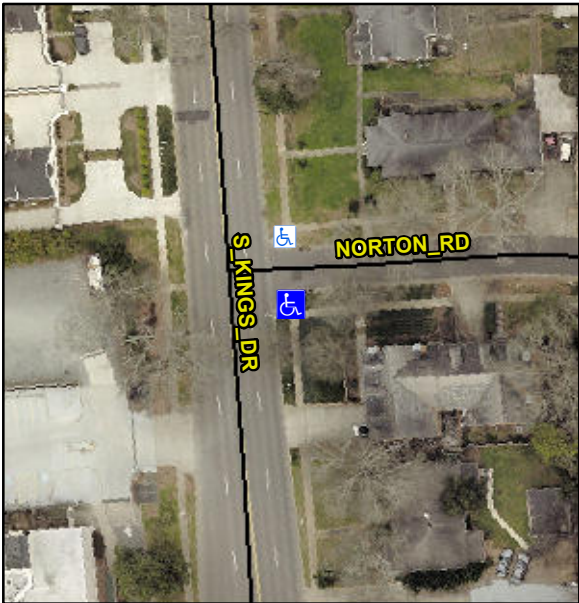
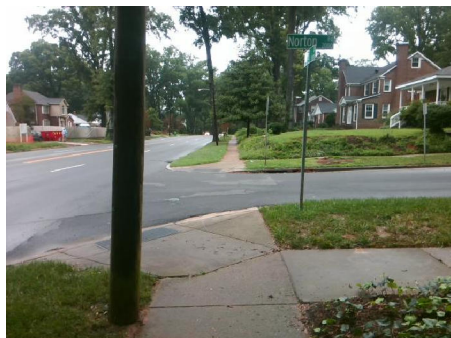
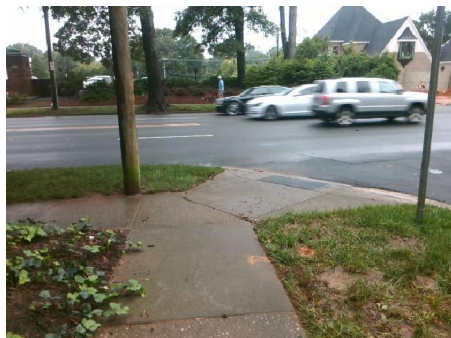
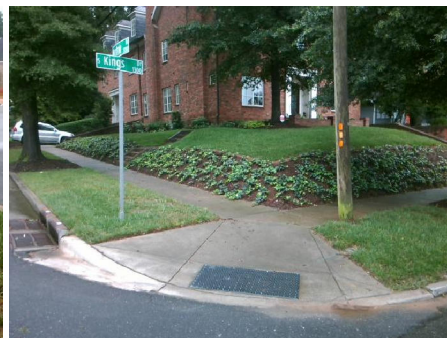
Possible Solutions:		Remove & Replace Curb Ramp With Two New Directional Ramps or Equivalent.					
	Surveyor Notes:		N/A					
	PROW/ADA:		Not Found, R304.2.2, R304.5.3					
	Total Cost:		\$ 3200.00					
Street 1 Name	NORTON RD		Compliance	Description	Data	Compliance	Description	Data
Stop Condition-Street 2	StopSign		N/A	Ramp Length (in)	87.0	No	Ramp Slope (%)	8.8
Street 2 Name	S KINGS DR		Yes	Ramp Width (in)	60.0	No	Ramp XSlope (%)	3.5
Stop Condition-Street 1	None		N/A	Flare Type LT	N/A	N/A	Flare Type RT	N/A
			N/A	Flare Slope LT (%)	N/A	N/A	Flare Slope RT (%)	N/A
			N/A	Flare Traversable LT?	N/A	N/A	Flare Traversable RT?	N/A
			N/A	Landing Length (in)	N/A	N/A	DWS Provided?	N/A
			N/A	Landing Width (in)	N/A	N/A	DWS Contrast?	N/A
			N/A	Landing Slope (%)	N/A	N/A	DWS Length (in)	N/A
			N/A	Landing X Slope (%)	N/A	N/A	DWS Full Width?	N/A

N/A	Landing Curb? (Y/N)	N/A	N/A	DWS Offset (in)	N/A
			N/A	Shared Landing?	N/A			
			N/A	Gutter Ponding?	N/A	N/A	Gutter Slope (%)	N/A
			N/A	Gutter Lip Ht (in)	N/A	N/A	Gutter X Slope (%)	N/A
			N/A	Painted X Walk1?	No	N/A	Painted X Walk2?	No
				X Walk 1 Direction	To N		X Walk 2 Direction	To W
			N/A	X Walk 1 Width (in)	N/A	N/A	X Walk 2 Width (in)	N/A
				X Walk 1 Slope (%)	4.5		X Walk 2 Slope (%)	3.1
				X Walk 1 X Slope (%)	3.6		X Walk 2 X Slope (%)	2.6
			N/A	Ramp inside XWalk1?	N/A	N/A	Ramp inside XWalk2?	N/A
				Road Slope (%)	0.5	N/A	Clear Space?	N/A
				Road X Slope (%)	4.3	N/A	Clear Space to XWalk (in)	N/A
			N/A	Any Obstructions?	N/A	N/A	Storm Grate/Utility Hazard?	N/A
				Obstruction Type			Storm Grate/Utility Type	
					N/A			N/A
						Yes	Surface Condition? (G/P)	Good
