## Access Compliance Report Public Rights-of-Way (Curb Ramps)

Intersection ID: 24534 Main Street: MALLOW\_PL Cross Street: SAINTFIELD\_PL Location: SE

ADA ID: 814F11C7F9CC Ramp Type: PerpDiag Initial Pass/Fail: Fail Overall Compliance: No Severity Score: 13.75

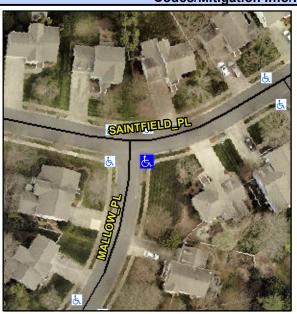
Not Found, R304.2.2, R304.5.3

| r leid Measurements/Component Compnance | | | | | |
|---|---|---|---|---|---|
| N/A | Ramp Length (in) | 48.0 | No | Ramp Slope (%) | 8.4 |
| Yes | Ramp Width (in) | 48.0 | No | Ramp XSlope (%) | 2.2 |

Remove & Replace Curb Ramp With Two New Directional Ramps or Equivalent.
