# Access Compliance Report

## Public Rights-of-Way

### (Curb Ramps)

Intersection ID: 7225	Main Street: STATESVILLE_RD	Cross Street: STARITA_RD	Location: SE
ADA ID: 815808A1E064	Ramp Type: Para	Initial Pass/Fail: Fail	Overall Compliance: No
Severity Score: 13.75			
Codes/Mitigation Info/Possible Solution		Field Measurements/Component Compliance

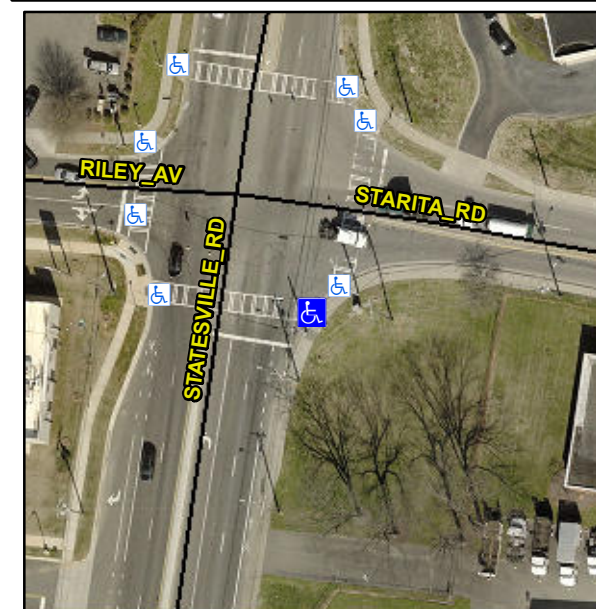
Compliance	Description	Data	Compliance	Description	Data
N/A	Ramp Length LT (in)	6.5	N/A	Ramp Length RT (in)	61.0
Yes	Ramp Width LT (in)	83.5	Yes	Ramp Width RT (in)	84.0
Yes	Ramp Slope LT (%)	5.9	No	Ramp Slope RT (%)	10.4
No	Ramp XSlope LT (%)	2.1	Yes	Ramp XSlope RT (%)	2.0
N/A	Landing Length (in)	N/A	N/A	DWS Provided?	N/A
N/A	Landing Width (in)	N/A	N/A	DWS Contrast?	N/A
N/A	Landing Slope (%)	N/A	N/A	DWS Length (in)	N/A
N/A	Landing X Slope (%)	N/A	N/A	DWS Full Width?	N/A
N/A	Landing Curb? (Y/N)	N/A	N/A	DWS Offset (in)	N/A
N/A	Shared Landing?	N/A			
N/A	Gutter Ponding?	N/A	N/A	Gutter Slope (%)	N/A
N/A	Gutter Lip Ht (in)	N/A	N/A	Gutter X Slope (%)	N/A
N/A	Painted X Walk1?	No	N/A	Painted X Walk2?	N/A
	X Walk 1 Direction	To W		X Walk 2 Direction	N/A
N/A	X Walk 1 Width (in)	N/A	N/A	X Walk 2 Width (in)	N/A
	X Walk 1 Slope (%)	2.8		X Walk 2 Slope (%)	N/A
	X Walk 1 X Slope (%)	0.6		X Walk 2 X Slope (%)	N/A
N/A	Ramp inside XWalk1?	N/A	N/A	Ramp inside XWalk2?	N/A

Road Slope (%)	N/A	N/A	Clear Space?	N/A
	Road X Slope (%)	N/A	N/A	Clear Space to XWalk (in)	N/A
N/A	Any Obstructions?	N/A	N/A	Storm Grate/Utility Hazard?	N/A
	Obstruction Type			Storm Grate/Utility Type	
		N/A			N/A
			Yes	Surface Condition? (G/P)	Good
			N/A	Curb Slope (%)	N/A

Possible Solutions:

**Remove & Replace Entire Ramp.**

**R304.5.3, R304.3.2**
