# Access Compliance Report

## Public Rights-of-Way

### (Curb Ramps)

Intersection ID: 47911	Main Street: ROOK_RD	Cross Street: RINGNECK_RD	Location: NE
ADA ID: 815FC05D6C72	Ramp Type: PerpDiag	Initial Pass/Fail: Fail	Overall Compliance: No
Codes/Mitigation Info/Possible Solution		Field Measurements/Component Compliance	
Severity Score: 46.25

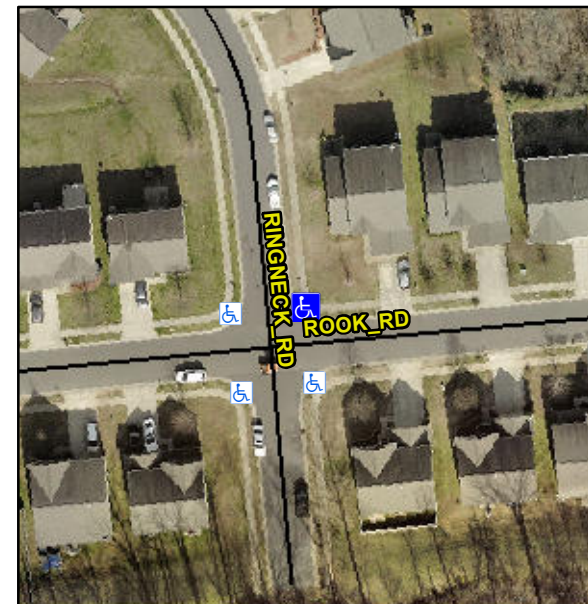
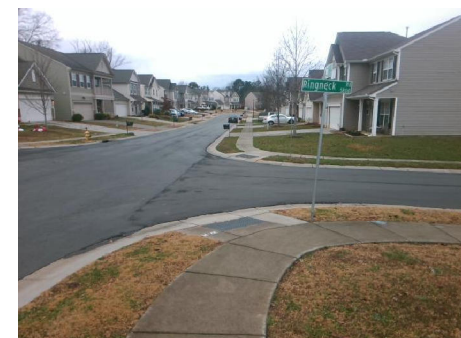
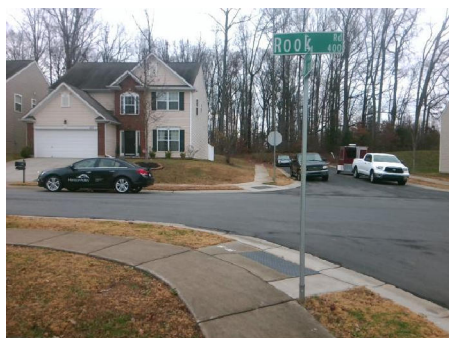
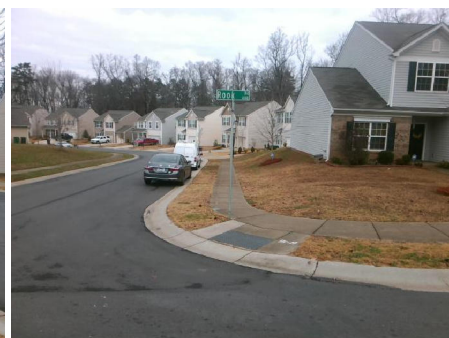
**Not Found, R304.5.1, R304.2.2, R304.5.3**

Compliance	Description	Data	Compliance	Description	Data
N/A	Ramp Length (in)	44.5	No	Ramp Slope (%)	8.7
No	Ramp Width (in)	47.5	No	Ramp XSlope (%)	8.0
N/A	Flare Type LT	N/A	N/A	Flare Type RT	N/A
N/A	Flare Slope LT (%)	N/A	N/A	Flare Slope RT (%)	N/A
N/A	Flare Traversable LT?	N/A	N/A	Flare Traversable RT?	N/A
N/A	Landing Length (in)	N/A	N/A	DWS Provided?	N/A
N/A	Landing Width (in)	N/A	N/A	DWS Contrast?	N/A
N/A	Landing Slope (%)	N/A	N/A	DWS Length (in)	N/A
N/A	Landing X Slope (%)	N/A	N/A	DWS Full Width?	N/A
N/A	Landing Curb? (Y/N)	N/A	N/A	DWS Offset (in)	N/A
N/A	Shared Landing?	N/A			
N/A	Gutter Ponding?	N/A	N/A	Gutter Slope (%)	N/A
N/A	Gutter Lip Ht (in)	N/A	N/A	Gutter X Slope (%)	N/A
N/A	Painted X Walk1?	No	N/A	Painted X Walk2?	No
	X Walk 1 Direction	To W		X Walk 2 Direction	To S
N/A	X Walk 1 Width (in)	N/A	N/A	X Walk 2 Width (in)	N/A
	X Walk 1 Slope (%)	2.2		X Walk 2 Slope (%)	6.2
	X Walk 1 X Slope (%)	4.4		X Walk 2 X Slope (%)	3.4

N/A	Ramp inside XWalk1?	N/A	N/A	Ramp inside XWalk2?	N/A
	Road Slope (%)	6.5	N/A	Clear Space?	N/A
	Road X Slope (%)	1.3	N/A	Clear Space to XWalk (in)	N/A
N/A	Any Obstructions?	N/A	N/A	Storm Grate/Utility Hazard?	N/A
	Obstruction Type			Storm Grate/Utility Type	
		N/A			N/A
			Yes	Surface Condition? (G/P)	Good

**Remove & Replace Curb Ramp With Two New Directional Ramps or Equivalent.**

Total Cost: \$ **3200.00**
