Access Compliance Report Public Rights-of-Way (Curb Ramps)

Intersection ID: 48884Main Street:REINBECK_DRCross Street: OLD_POTTERS_RDLocation:WADA ID: 8168C5652B7ARamp Type:PerpInitial Pass/Fail:FailOverall Compliance: NoSeverity Score:22.5

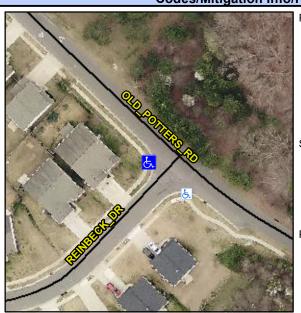
Not Found, R304.5.1, R304.2.2, R304.5.3

Field Measurements/Component Compnance						
Comp	liance Description	Data	Comp	liance Description	Data	
N/A	Ramp Length (in)	48.0	No	Ramp Slope (%)	9.8	
No	Ramp Width (in)	47.5	No	Ramp XSlope (%)	3.9	
N/A	Flare Type LT	N/A	N/A	Flare Type RT	N/A	
N/A	Flare Slope LT (%)	N/A	N/A	Flare Slope RT (%)	N/A	
N/A	Flare Traversable LT?	N/A	N/A	Flare Traversable RT?	N/A	
N/A	Landing Length (in)	N/A	N/A	DWS Provided?	N/A	
N/A	Landing Width (in)	N/A	N/A	DWS Contrast?	N/A	
N/A	Landing Slope (%)	N/A	N/A	DWS Length (in)	N/A	
N/A	Landing X Slope (%)	N/A	N/A	DWS Full Width?	N/A	
N/A	Landing Curb? (Y/N)	N/A	N/A	DWS Offset (in)	N/A	
N/A	Shared Landing?	N/A				
N/A	Gutter Ponding?	N/A	N/A	Gutter Slope (%)	N/A	
N/A	Gutter Lip Ht (in)	N/A	N/A	Gutter X Slope (%)	N/A	
N/A	Painted X Walk1?	No	N/A	Painted X Walk2?	N/A	
	X Walk 1 Direction	To SE		X Walk 2 Direction	N/A	
N/A	X Walk 1 Width (in)	N/A	N/A	X Walk 2 Width (in)	N/A	
	X Walk 1 Slope (%)	1.6		X Walk 2 Slope (%)	N/A

X Walk 1 X Slope (%)	1.8		X Walk 2 X Slope (%)	N/A	
N/A	Ramp inside XWalk1?	N/A	N/A	Ramp inside XWalk2?	N/A	
	Road Slope (%)	N/A	N/A	Clear Space?	N/A	
	Road X Slope (%)	N/A	N/A	Clear Space to XWalk (in)	N/A	
N/A	Any Obstructions?	N/A	N/A	Storm Grate/Utility Hazard?	N/A	
	Obstruction Type		l	Storm Grate/Utility Type		
		N/A			N/A	
			Yes	Surface Condition? (G/P)	Good

Remove & Replace Entire Ramp.

Total Cost: \$ 1850.00
