Access Compliance Report

Public Rights-of-Way

(Curb Ramps)

Intersection ID: 46810	Main Street: ARBOR_VISTA_DR	Cross Street: CLAUDE_FREEMAN_DR	Location: S
ADA ID: 8169FAA24F43	Ramp Type: Combination1	Initial Pass/Fail: Fail	Overall Compliance: No
			Severity Score: 26.25

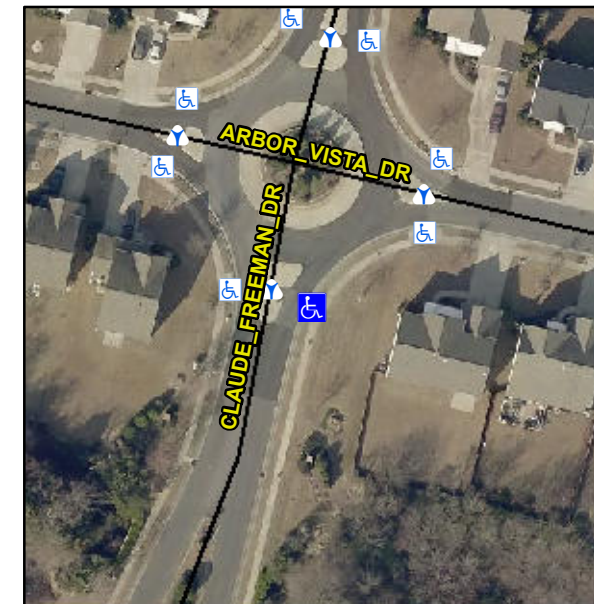
RT RP < 5%

R304.2.2, R304.5.3, R304.3.2

Compliance	Description	Data	Compliance	Description	Data
N/A	Ramp Length LT (in)	62.0	N/A	Ramp Length RT (in)	65.0
Yes	Ramp Width LT (in)	48.0	Yes	Ramp Width RT (in)	48.0
No	Ramp Slope LT (%)	8.7	Yes	Ramp Slope RT (%)	3.8
Yes	Ramp XSlope LT (%)	1.7	No	Ramp XSlope RT (%)	2.2
N/A	Ramp Length (in)	48.0	No	Ramp Slope (%)	17.8
Yes	Ramp Width (in)	49.0	No	Ramp XSlope (%)	3.5
N/A	Flare Type LT	N/A	N/A	Flare Type RT	N/A
N/A	Flare Slope LT (%)	N/A	N/A	Flare Slope RT (%)	N/A
N/A	Flare Traversable LT?	N/A	N/A	Flare Traversable RT?	N/A
N/A	Landing Length (in)	N/A	N/A	DWS Provided?	N/A
N/A	Landing Width (in)	N/A	N/A	DWS Contrast?	N/A
N/A	Landing Slope (%)	N/A	N/A	DWS Length (in)	N/A
N/A	Landing X Slope (%)	N/A	N/A	DWS Full Width?	N/A
N/A	Landing Curb? (Y/N)	N/A	N/A	DWS Offset (in)	N/A
N/A	Shared Landing?	N/A			
N/A	Gutter Ponding?	N/A	N/A	Gutter Slope (%)	N/A
N/A	Gutter Lip Ht (in)	N/A	N/A	Gutter X Slope (%)	N/A
N/A	Painted X Walk1?	No	N/A	Painted X Walk2?	N/A

Remove & Replace Entire Ramp.

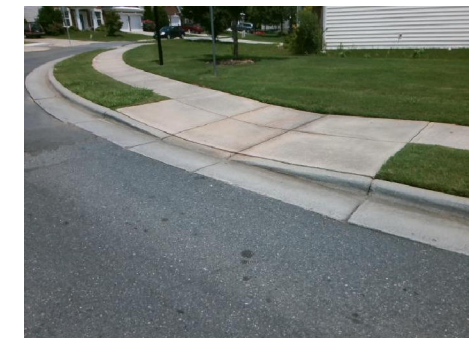
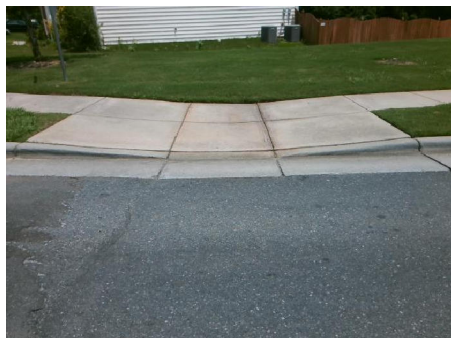
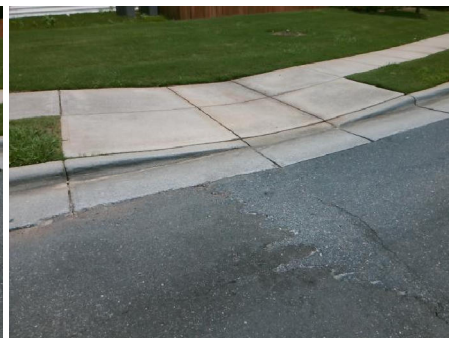
X Walk 1 Direction	To W		X Walk 2 Direction	N/A
	X Walk 1 Width (in)	N/A		X Walk 2 Width (in)	N/A
	X Walk 1 Slope (%)	2.5		X Walk 2 Slope (%)	N/A
	X Walk 1 X Slope (%)	3.7		X Walk 2 X Slope (%)	N/A
N/A	Ramp inside XWalk1?	N/A	N/A	Ramp inside XWalk2?	N/A
	Road Slope (%)	N/A		Clear Space?	N/A
	Road X Slope (%)	N/A	N/A	Clear Space to XWalk (in)	N/A
			N/A	Any Obstruction?	N/A
				Obstruction Type	N/A
			N/A	Storm Grate/Utility Hazard?	N/A
				Storm Grate/Utility Type	N/A
					N/A
Yes	Surface Condition? (G/P)	Good			
	Curb Slope (%)	N/A
