Access Compliance Report

Public Rights-of-Way

| Intersection ID: 8070 | Main Street: LITTLE ROCK RD | Cross Street: PAW CREEK RD | Location: E |
| ADA ID: 816CE4450F6C | Ramp Type: BlendTrans2 | Initial Pass/Fail: Fail | Overall Compliance: No |

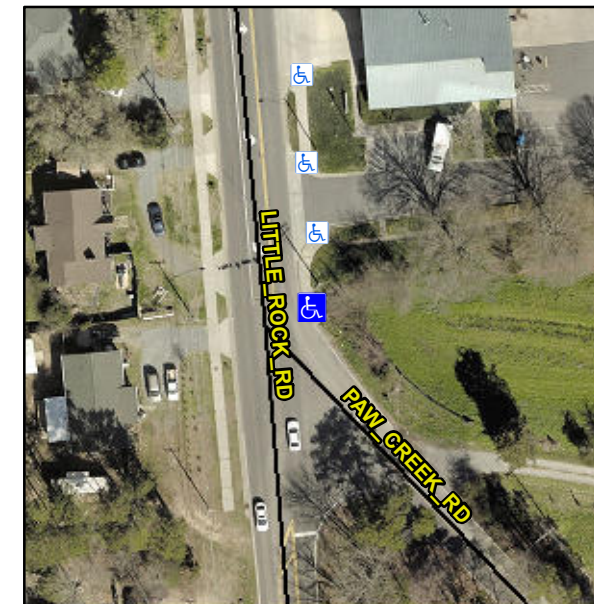
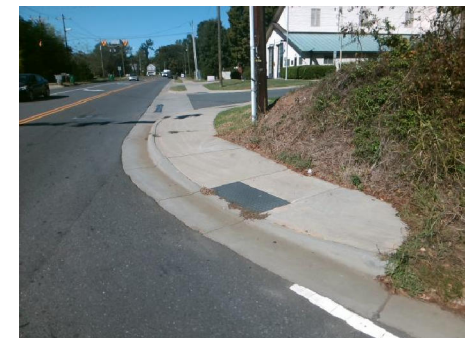
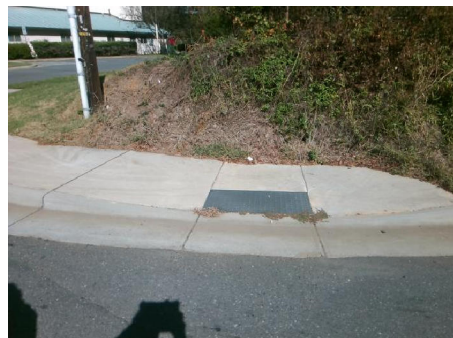
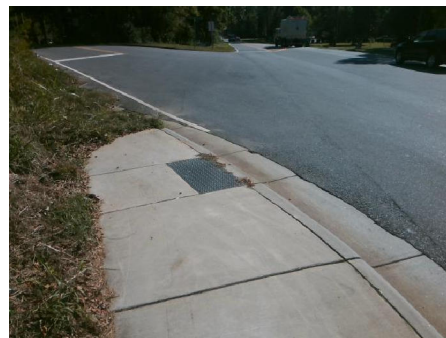
| | | Severity Score: 8.75 | |

Not Found, R304.5.1

| Compliance | Description | Data | Compliance | Description | Data |
|---|---|---|---|---|---|
| No | Ramp Width (in) | 46.0 | Yes | BlendTrans XSlope (%) | 1.4 |
| | | | No | Curb Slope (%) | 6.2 |

Remove & Replace Curb Ramp With Two New Directional Ramps or Equivalent.
