Access Compliance Report Public Rights-of-Way (Curb Ramps)

Intersection ID: 13679 Main Street: EUCLID_AV Cross Street: LEXINGTON_AV Location: S

ADA ID: 81784EBD394D Ramp Type: Directional1 Initial Pass/Fail: Fail Overall Compliance: No Severity Score: 1.25

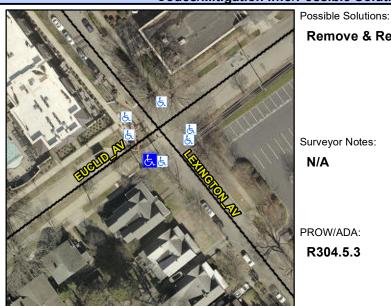
Comp	liance Description	Data	Comp	liance	Description	Data
N/A	Ramp Length (in)	68.0	N/A	Grad	e Break?	N/A
Yes	Ramp Width (in)	48.0	N/A	Grad	e Break Slope (%)	0.0
Yes	Ramp Slope (%)	7.7	N/A	Grad	e Break XSlope (%)	0.0
No	Ramp XSlope (%)	2.1				
N/A	Flare Type LT	N/A	N/A	Flare	Type RT	N/A
N/A	Flare Slope LT (%)	N/A	N/A	Flare	Slope RT (%)	0.0
N/A	Flare Traversable LT?	N/A	N/A	Flare	Traversable RT?	N/A
N/A	Landing Length (in)	0.0	N/A	DWS	Provided?	N/A
N/A	Landing Width (in)	0.0	N/A	DWS	Contrast?	N/A
N/A	Landing Slope (%)	0.0	N/A	DWS	Length (in)	N/A
N/A	Landing X Slope (%)	0.0	N/A	DWS	Full Width?	N/A
N/A	Landing Curb? (Y/N)	N/A	N/A	DWS	Offset LT (in)	N/A
N/A	Shared Landing?	N/A	N/A	DWS	Offset RT (in)	N/A
N/A	Gutter Ponding?	Yes	N/A	Gutte	r Slope (%)	N/A
N/A	Gutter Lip Ht (in)	0.0	N/A	Gutte	r X Slope (%)	N/A
N/A	Painted X Walk1?	No		Road	Slope (%)	8.4
	X Walk 1 Direction	To NW	To NW		X Slope (%)	3.0
	X Walk 1 Width (in)	N/A		Clear	Space?	N/A

X Walk 1 Slope (%)	8.4	N/A	Clear	Space to XWalk (in)	N/A
	X Walk 1 X Slope (%)	3.0	N/A	Storn	n Grate/Utility Hazard?	N/A
N/A	Ramp inside XWalk1?	N/A		Storn	n Grate/Utility Type	
N/A	Any Obstructions?	N/A				N/A
	Obstruction Type		Yes	Surfa	ce Condition? (G/P)	Good
		N/A	N/A	Curb	Slope (%)	20.1

Remove & Replace Entire Ramp.

PROW/ADA:
R304.5.3
