Access Compliance Report

Public Rights-of-Way

(Curb Ramps)

Intersection ID: 16072	Main Street: MONROE_RD	Cross Street: RICHLAND_DR	Location: SW
ADA ID: 817A0BF257DE	Ramp Type: Perp	Initial Pass/Fail: Fail	Overall Compliance: No
		Severity Score: 10

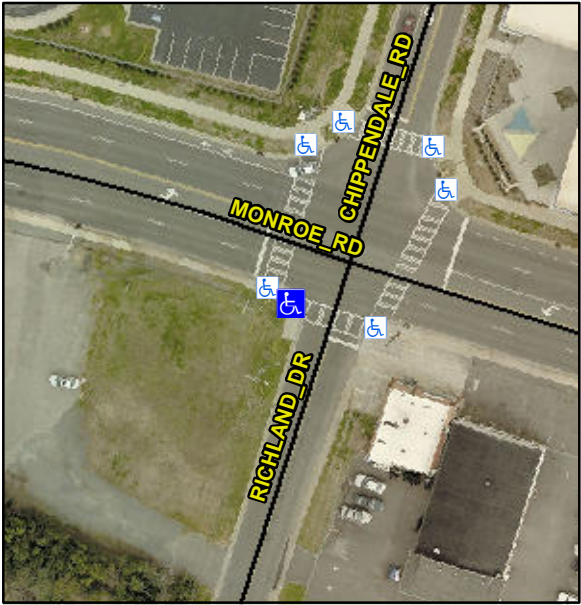
Possible Solutions:		Compliance	Description	Data
	Remove & Replace Entire Ramp.		N/A	Ramp Length (in)	72.0
			No	Ramp Width (in)	40.5
			N/A	Flare Type LT	N/A
			N/A	Flare Slope LT (%)	N/A
			N/A	Flare Traversable LT?	N/A
			N/A	Landing Length (in)	N/A
			N/A	Landing Width (in)	N/A
			N/A	Landing Slope (%)	N/A
			N/A	Landing X Slope (%)	N/A
<p>Surveyor Notes:</p> <p>N/A</p> <p>PROW/ADA:</p> <p>Not Found, R304.5.1</p>			N/A	Flare Type RT	N/A
			N/A	Flare Slope RT (%)	N/A
			N/A	Flare Traversable RT?	N/A
			N/A	DWS Provided?	N/A
			N/A	DWS Contrast?	N/A
			N/A	DWS Length (in)	N/A
			N/A	DWS Full Width?	N/A
			N/A	DWS Offset (in)	N/A
			N/A	Gutter Ponding?	N/A
			N/A	Gutter Lip Ht (in)	N/A
			N/A	Painted X Walk1?	Yes
				X Walk 1 Direction	To E
			N/A	X Walk 1 Width (in)	115.0
				X Walk 1 Slope (%)	2.8
				X Walk 1 X Slope (%)	3.5

N/A	Ramp inside XWalk1?	Yes
				Road Slope (%)	N/A
				Road X Slope (%)	N/A
			N/A	Any Obstructions?	N/A
				Obstruction Type	
Total Cost: \$ 1850.00					
			N/A	Clear Space?	N/A
				Clear Space to XWalk (in)	N/A
			N/A	Storm Grate/Utility Hazard?	N/A
				Storm Grate/Utility Type	
			N/A		N/A
			Yes	Surface Condition? (G/P)	Good
