Access Compliance Report

Public Rights-of-Way

(Curb Ramps)

Intersection ID: 14286	Main Street: S_TORRENCE_ST	Cross Street: MAIN_ST	Location: E
ADA ID: 8187962543A2	Ramp Type: PerpDiag	Initial Pass/Fail: Fail	Overall Compliance: No
Severity Score: 8.75			
Codes/Mitigation Info/Possible Solution		Field Measurements/Component Compliance

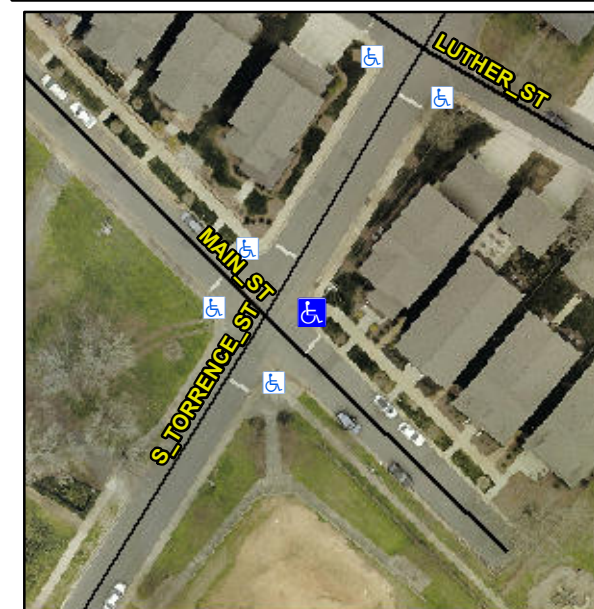
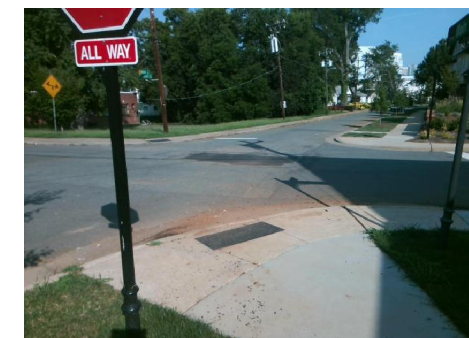
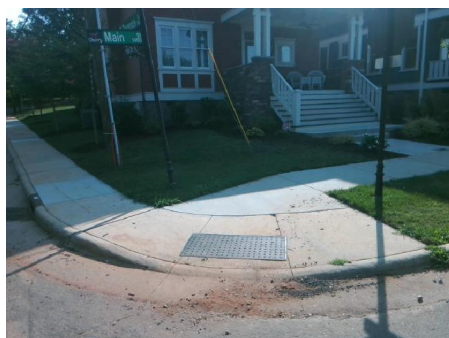
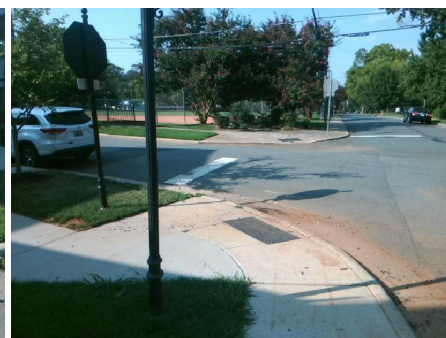
Not Found, R304.5.1

Compliance	Description	Data	Compliance	Description	Data
N/A	Ramp Length (in)	54.0	Yes	Ramp Slope (%)	7.2
No	Ramp Width (in)	36.0	Yes	Ramp XSlope (%)	1.4
N/A	Flare Type LT	N/A	N/A	Flare Type RT	N/A
N/A	Flare Slope LT (%)	N/A	N/A	Flare Slope RT (%)	N/A
N/A	Flare Traversable LT?	N/A	N/A	Flare Traversable RT?	N/A
N/A	Landing Length (in)	N/A	N/A	DWS Provided?	N/A
N/A	Landing Width (in)	N/A	N/A	DWS Contrast?	N/A
N/A	Landing Slope (%)	N/A	N/A	DWS Length (in)	N/A
N/A	Landing X Slope (%)	N/A	N/A	DWS Full Width?	N/A
N/A	Landing Curb? (Y/N)	N/A	N/A	DWS Offset (in)	N/A
N/A	Shared Landing?	N/A			
N/A	Gutter Ponding?	Yes	N/A	Gutter Slope (%)	N/A
N/A	Gutter Lip Ht (in)	N/A	N/A	Gutter X Slope (%)	N/A
N/A	Painted X Walk1?	No	N/A	Painted X Walk2?	No
	X Walk 1 Direction	To NW		X Walk 2 Direction	To SW
N/A	X Walk 1 Width (in)	N/A	N/A	X Walk 2 Width (in)	N/A
	X Walk 1 Slope (%)	1.2		X Walk 2 Slope (%)	0.6
	X Walk 1 X Slope (%)	1.5		X Walk 2 X Slope (%)	1.5

N/A	Ramp inside XWalk1?	N/A	N/A	Ramp inside XWalk2?	N/A
	Road Slope (%)	1.3	N/A	Clear Space?	N/A
	Road X Slope (%)	0.0	N/A	Clear Space to XWalk (in)	N/A
N/A	Any Obstructions?	N/A	N/A	Storm Grate/Utility Hazard?	N/A
	Obstruction Type			Storm Grate/Utility Type	
		N/A			N/A
		Yes		Surface Condition? (G/P)	Good

Possible Solutions:

Remove & Replace Curb Ramp With Two New Directional Ramps or Equivalent.
