Access Compliance Report

Public Rights-of-Way

(Curb Ramps)

Intersection ID: 11422	Main Street: N_MCDOWELL_ST	Cross Street: PARKWOOD_AV	Location: SE
ADA ID: 81A8E7AEC3EE	Ramp Type: Perp	Initial Pass/Fail: Fail	Overall Compliance: No
Severity Score: 37.5			
Codes/Mitigation Info/Possible Solution		Field Measurements/Component Compliance

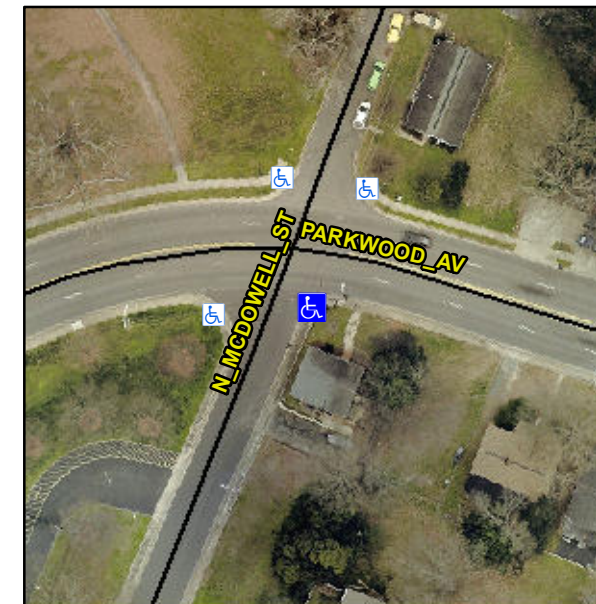
Not Found, R304.2.2, R304.5.3

Compliance	Description	Data	Compliance	Description	Data
N/A	Ramp Length (in)	53.0	No	Ramp Slope (%)	9.7
Yes	Ramp Width (in)	48.0	No	Ramp XSlope (%)	7.0
N/A	Flare Type LT	N/A	N/A	Flare Type RT	N/A
N/A	Flare Slope LT (%)	N/A	N/A	Flare Slope RT (%)	N/A
N/A	Flare Traversable LT?	N/A	N/A	Flare Traversable RT?	N/A
N/A	Landing Length (in)	N/A	N/A	DWS Provided?	N/A
N/A	Landing Width (in)	N/A	N/A	DWS Contrast?	N/A
N/A	Landing Slope (%)	N/A	N/A	DWS Length (in)	N/A
N/A	Landing X Slope (%)	N/A	N/A	DWS Full Width?	N/A
N/A	Landing Curb? (Y/N)	N/A	N/A	DWS Offset (in)	N/A
N/A	Shared Landing?	N/A			
N/A	Gutter Ponding?	N/A	N/A	Gutter Slope (%)	N/A
N/A	Gutter Lip Ht (in)	N/A	N/A	Gutter X Slope (%)	N/A
N/A	Painted X Walk1?	No	N/A	Painted X Walk2?	N/A
	X Walk 1 Direction	To W		X Walk 2 Direction	N/A
N/A	X Walk 1 Width (in)	N/A	N/A	X Walk 2 Width (in)	N/A
	X Walk 1 Slope (%)	4.0		X Walk 2 Slope (%)	N/A
	X Walk 1 X Slope (%)	3.2		X Walk 2 X Slope (%)	N/A

Remove & Replace Entire Ramp.
